TREC-7-6

PROPERTY INSPECTION REPORT FORM

5940 Fairbrook Dr, San Antonio, TX 78242

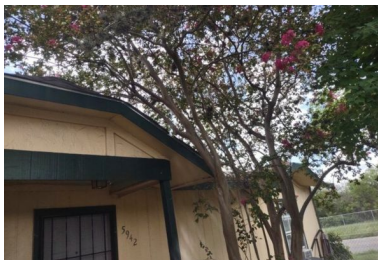
Tree(s) are contacting and/or overhanging the roof. This can lead to roof covering damage as well as excessive debris build-up resulting in a lack of drainage. Recommend having the trees trimmed in these locations by a qualified arborist.

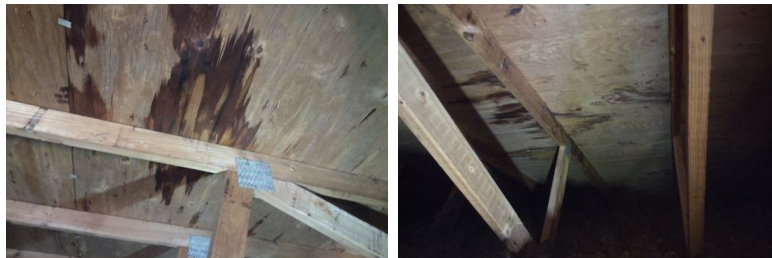
Moisture Stains in Attic: Moisture stained roof framing observed in the attic. No significant moisture damage observed. Any conditions observed on the roof that could allow moisture intrusion will be outlined in this report.

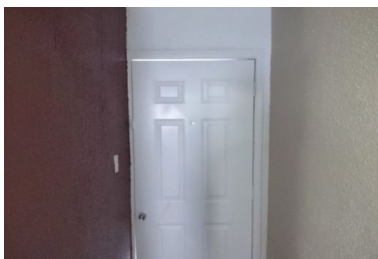
All Exterior entry doors at both units

The entry door does not appear to be adequately/fully sealed when closed. Recommend service/adjustment of the door (or replacement of the weather sealing components if needed) by a qualified door technician.

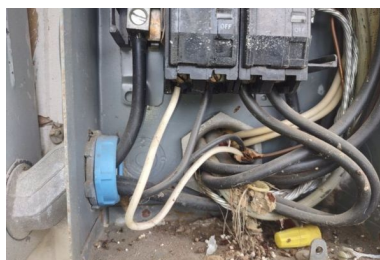
Both main service panels

Electrical conductors with white insulation are installed as line/hot. These conductors are to be installed as grounded/neutral conductors or should be correctly color coded if installed as a line/hot or equipment grounding conductor. Recommend application of appropriate color coding tape by a qualified electrician.

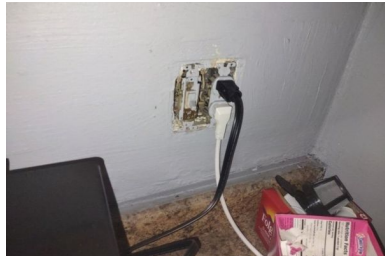
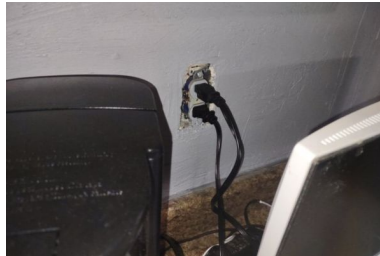
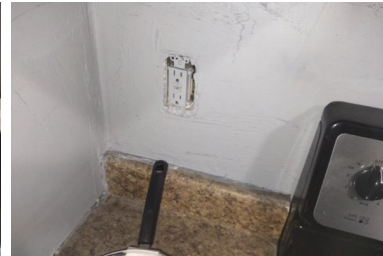
Kitchen unit 5942

Damaged/missing outlet cover(s) noted. Recommend replacement.

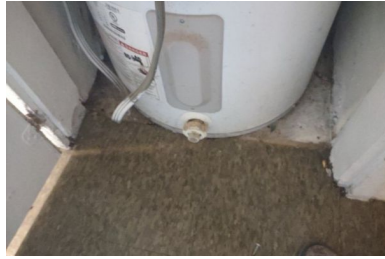
The water heater is installed in the interior of the home and there is no drip pan installed. Recommend the installation of a drip pan with a pipe to direct water away from framing and finish materials by a qualified

plumber.
