RENTAL INSPECTION REPORT

345 Rental Ave
Denver CO 80123

ABC Property
OCTOBER 31, 2018

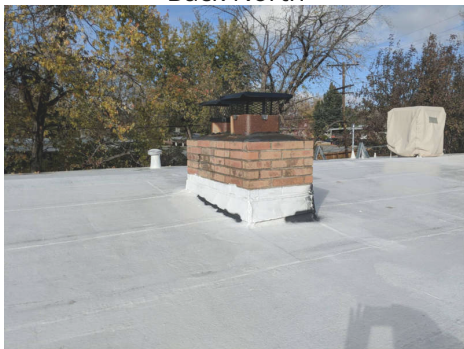
Chimney

There is minor cracking in the brick veneer present around the chimney.

Recommend monitoring.

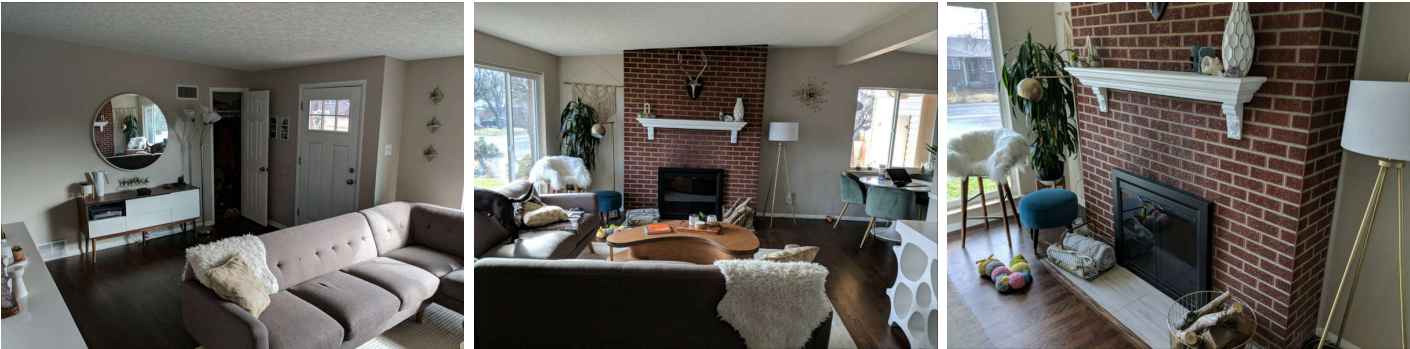
Fireplace

The fireplace was inspected and appears to be in good working condition at this time. The damper was functioning and the visible portion of the flue appears to be free of obstructions. However, the fire box and flue are dirty with soot and ash. Cleaning by a professional chimney sweep is recommended before using.

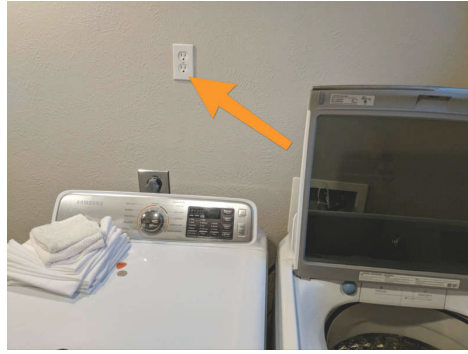
The electrical outlets are not protected by a GFCI outlet. While this may not have been required when the home was built, GFCI outlets provide protection from electric shock and are now required to be installed near sources of water, such as at kitchens, bathrooms, laundry rooms, and outdoors. I recommend that an electrician install GFCI outlets where needed for safety protection.

Not GFCI protected
