# INITIAL PROPERTY INSPECTION REPORT

# 709 E Blue Mesa Pl Vail, AZ 85641

Opendoor Mackenzie NOVEMBER 9, 2022

Inspector Dwell Inspect Arizona (Tucson) 4808674599 tucson@dwellinspectaz.com

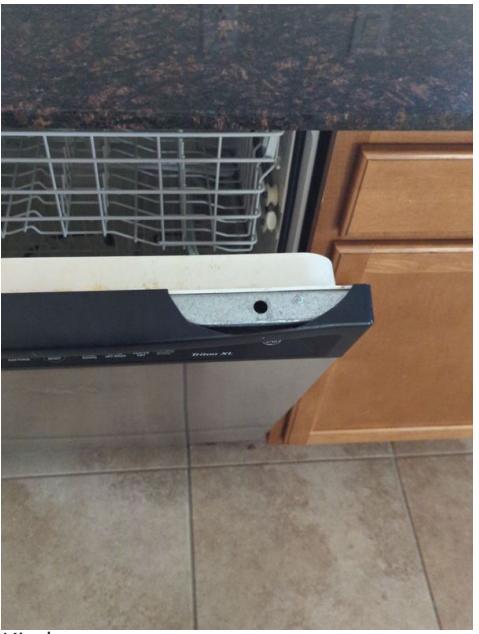
Kitchen

### SUPERFICIAL DAMAGE

There is superficial damage observed at the dishwasher.

Recommendation Contact a gualified professional.

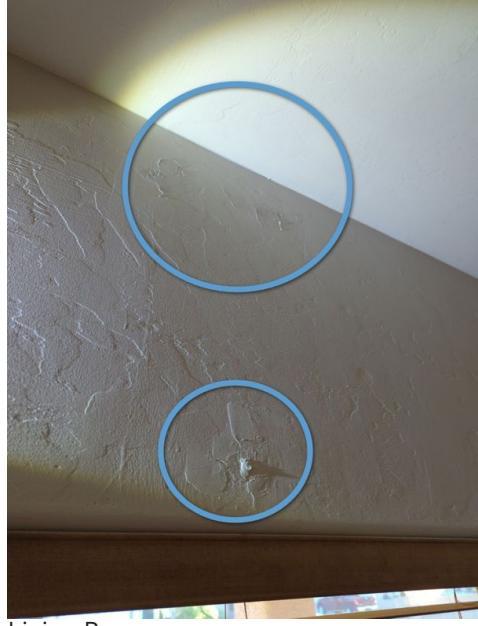
#### **INDICATIONS OF REPAIRS**

There are some indications of repairs observed in the drywall. Unable to determine the cause or condition of the underlying material. Recommend inquiring with the current owner/occupant to determine the history of the area.

Contact a qualified professional.

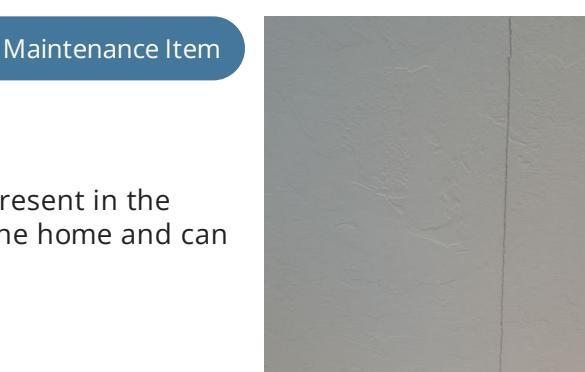
Garage

### **CEILING - SMALL SUPERFICIAL CRACKING/NAIL POPPING**

There is small and linear cracking or nail popping present in the ceiling finish. This does not impact the livability of the home and can be repaired at your discretion.

Contact a qualified professional.

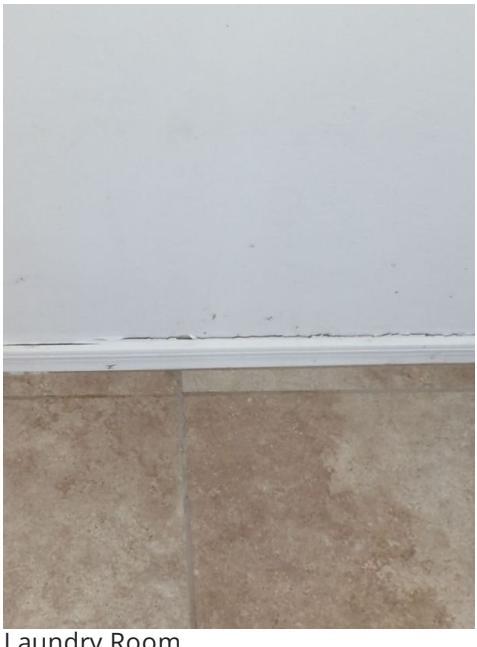
Laundry Room

### **TRIM MISSING/DAMAGED**

There is a section of trim that is missing. Recommend repair or replacement.

Recommendation Contact a qualified professional.

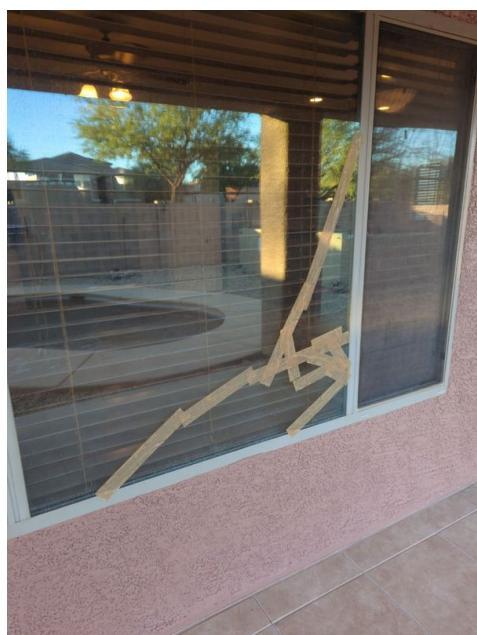
Living Room

# **BROKEN GLASS**

There are broken or cracked window panes. Recommend repair.

Contact a qualified window repair/installation contractor.

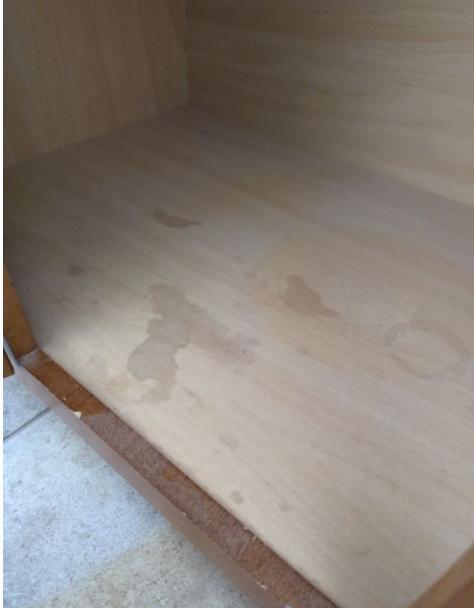
Kitchen

# **CABINETS - COMMON MOISTURE DAMAGE**

There is damage observed underneath the sink that is consistent with material storage or a previous plumbing leaking. Unable to determine the condition of the underlying material. Recommend repair as needed.

Contact a qualified professional.

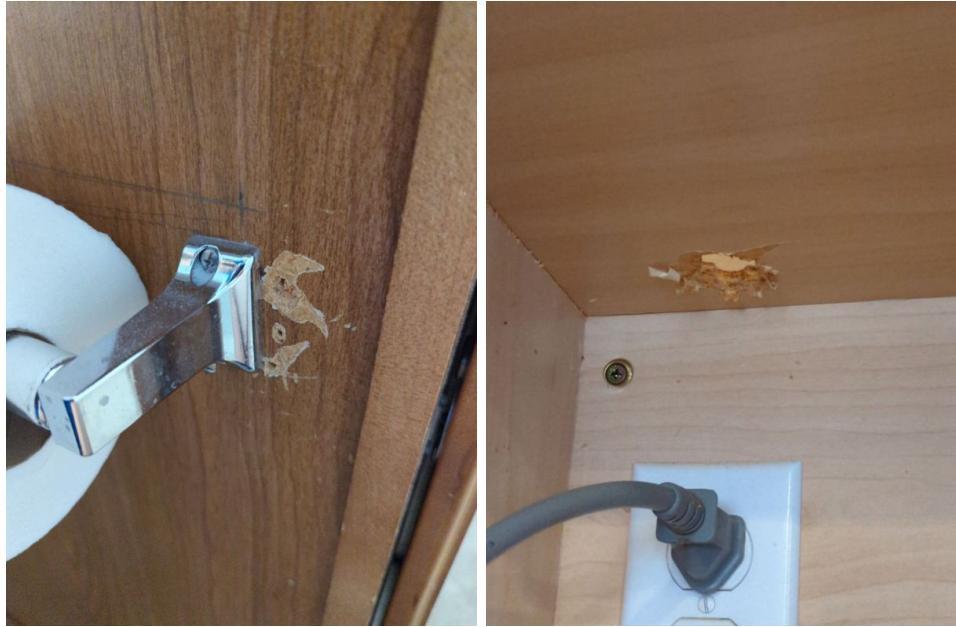
# 3.4.2 Counters/Cabinets CABINETS - LOOSE/DAMAGED

The cabinets are loose or damaged. Recommend repair.

Contact a qualified professional.

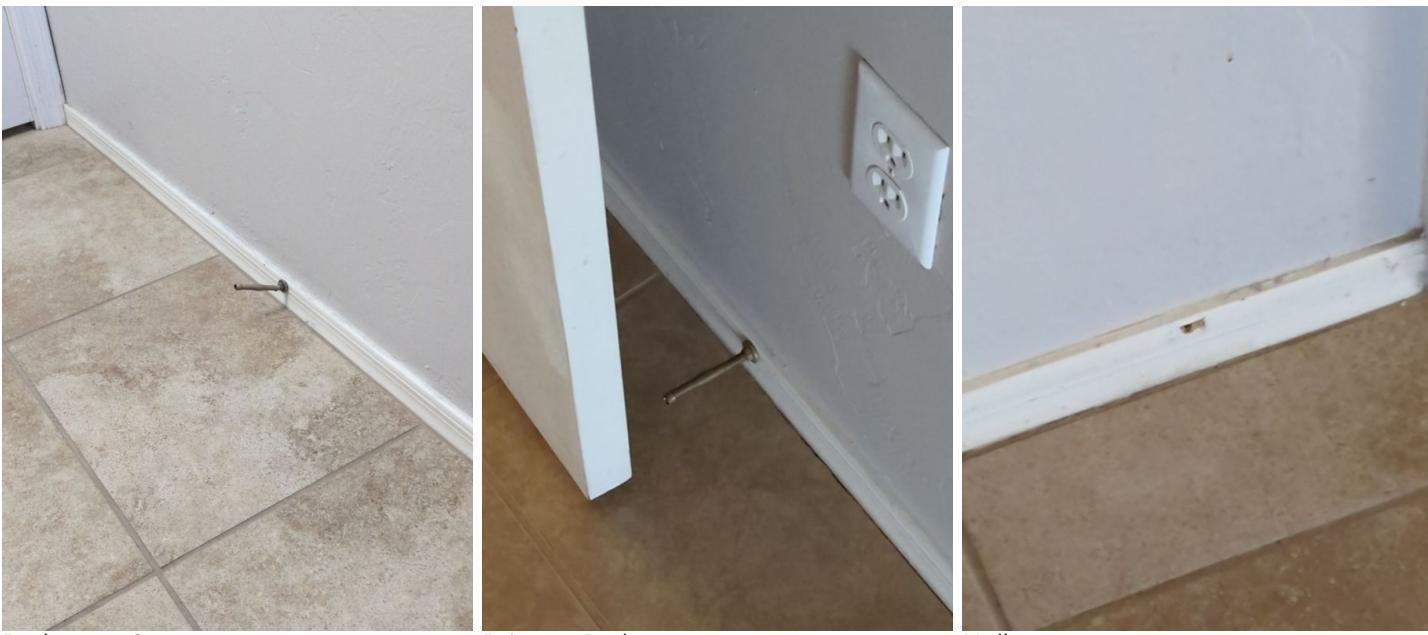
# 3.5.1 Doors and Closets REPLACE/ADD DOOR STOPPERS

Replace or add missing door stoppers to prevent damage to the drywall.

Recommendation Contact a qualified professional.

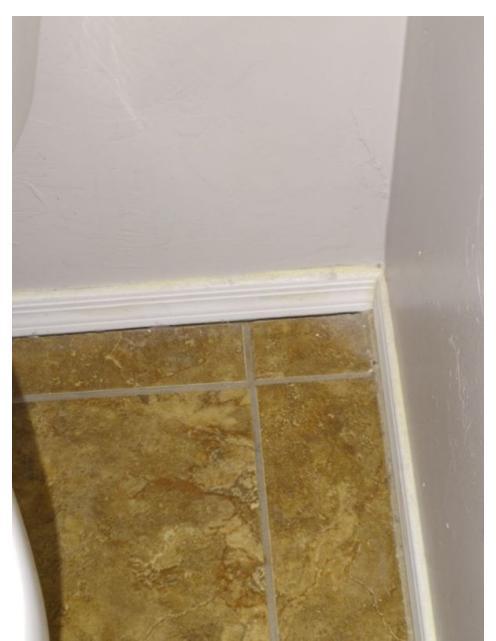
Primary Bathroom

There is gapping between the flooring material and the tub/shower base. Recommend sealing the area between the tub and the floor to help prevent water penetration to the sub floor.

Recommendation Contact a qualified professional.

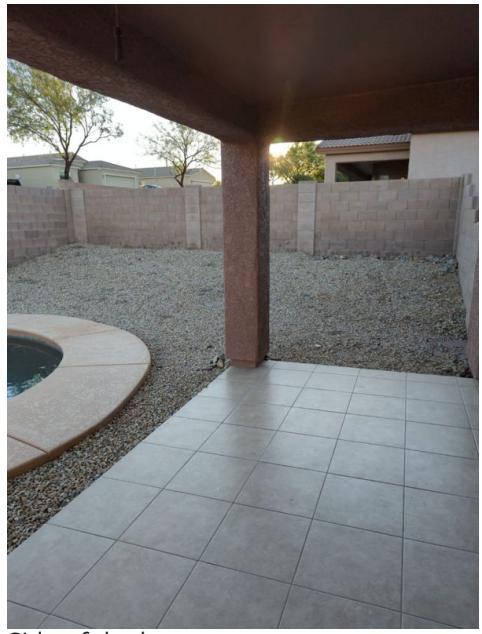
Side of the house

The lot is lower than adjacent lots. Grading improvements should be undertaken where possible. The general topography of the area is such that it will be difficult to control storm water entirely. During heavy rains, the accumulation of storm water on the lot may be unavoidable. This could cause water entry onto the property.

Contact a qualified landscaping contractor

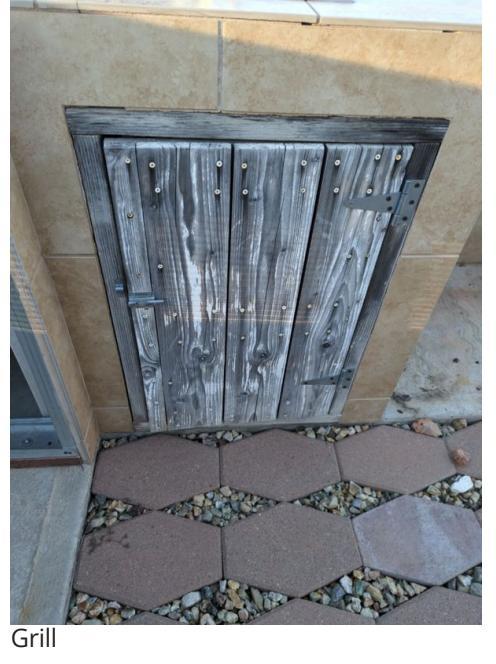
#### 5.5.1 Siding

Typical weathering is observed at the siding. This is common for the type of material. Recommend having the siding sealed and painted as regular maintenance. This includes the exterior trim at the joints of the siding and window perimeters, sections of which will likely need to be replaced.

Recommendation Contact a qualified professional.

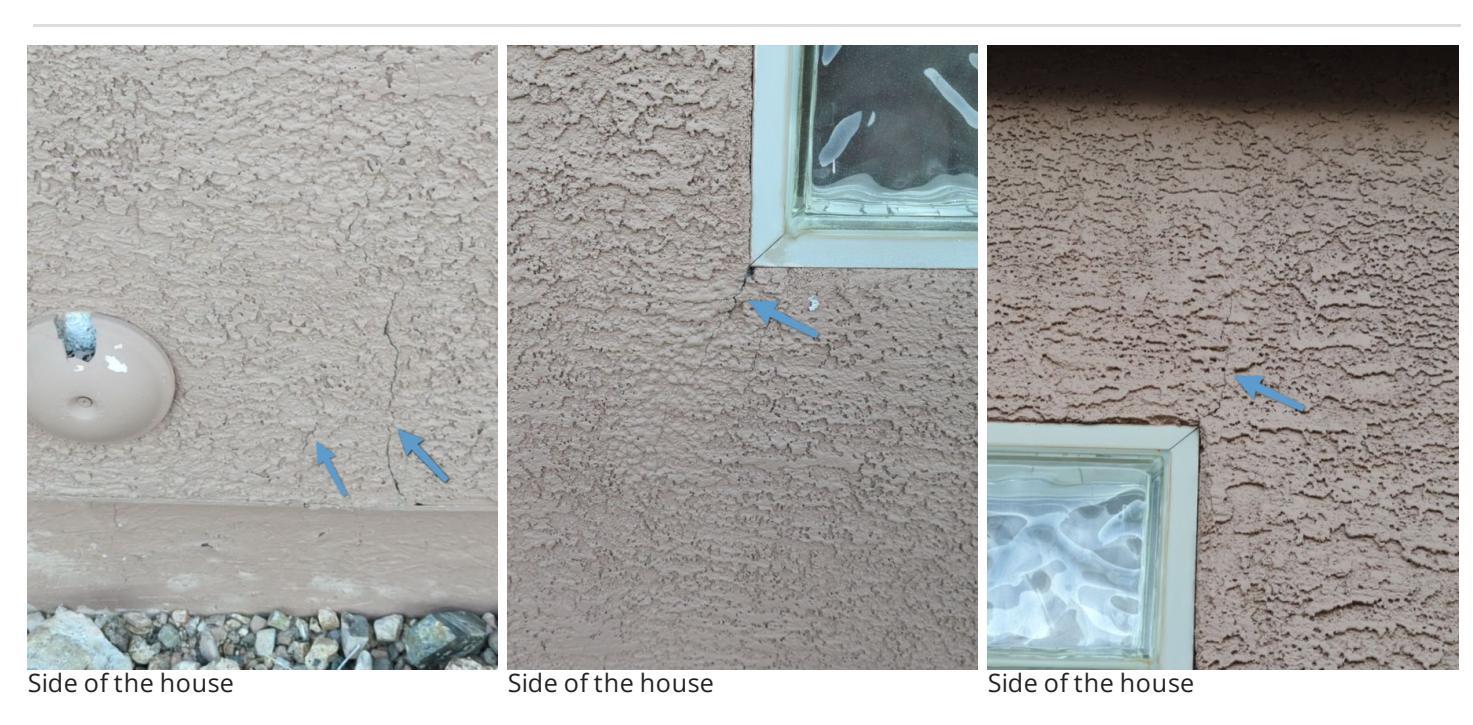
# 5.5.2 Siding STUCCO CRACKS - TYPICAL

There are cracks in the stucco. This is typical for this type of material. Repair as needed.

Recommendation Contact a qualified professional.

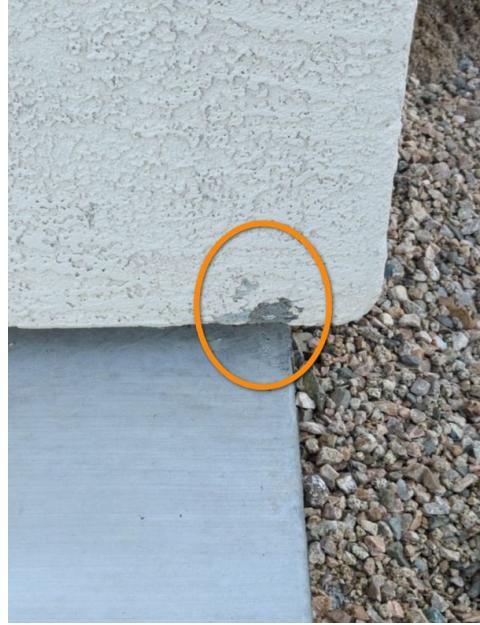
Front Side of the house

# 5.5.3 Siding **DAMAGED STUCCO**

There is damaged stucco finish observed. Recommend repair.

Recommendation Contact a qualified professional.

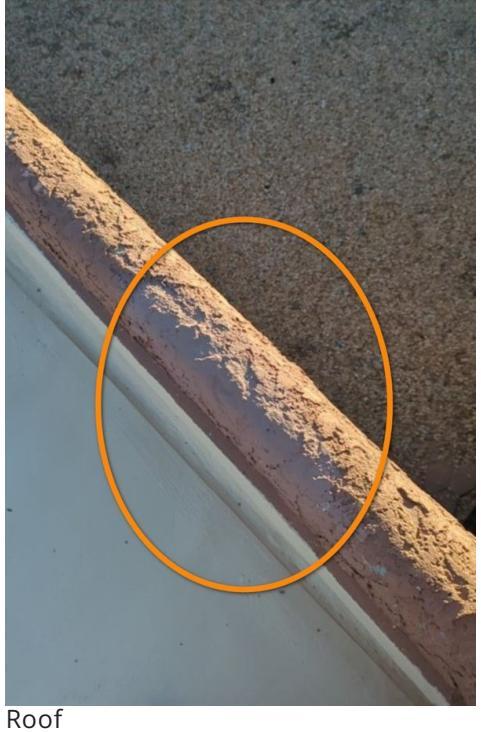
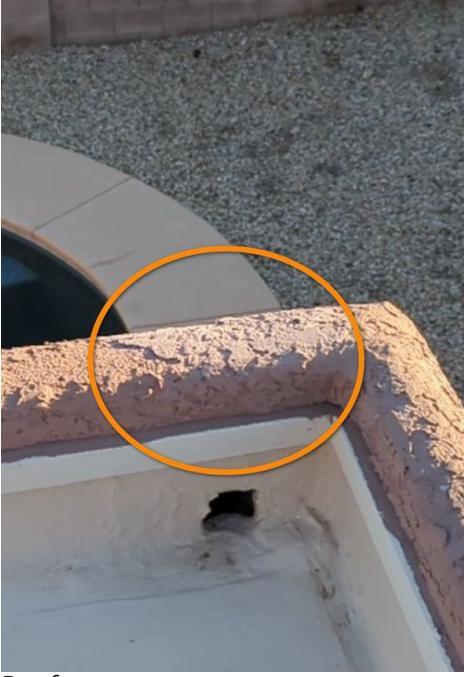
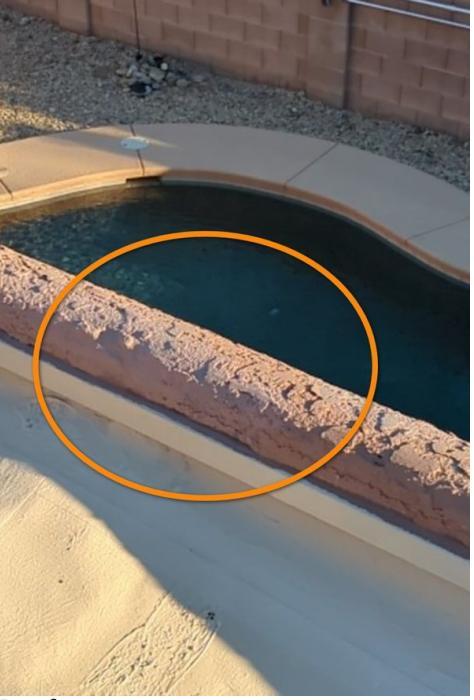
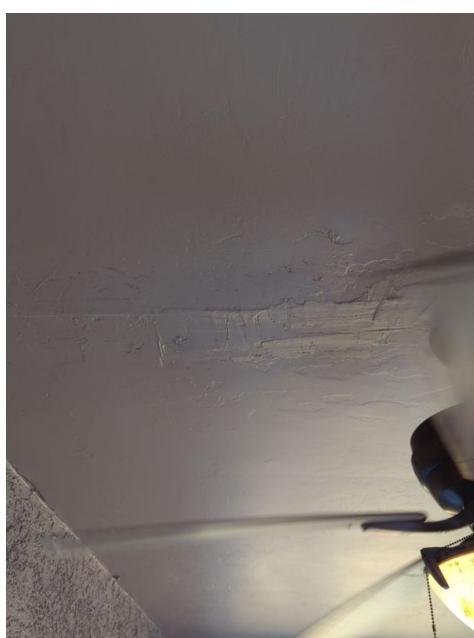
### 5.5.4 Siding **REPAIRS TO THE SIDING**

There are some indications of repairs observed in the siding. Unable to determine the cause or condition of the underlying material. Recommend consulting the owner for additional information and or further evaluation of the area.

Contact a qualified professional.

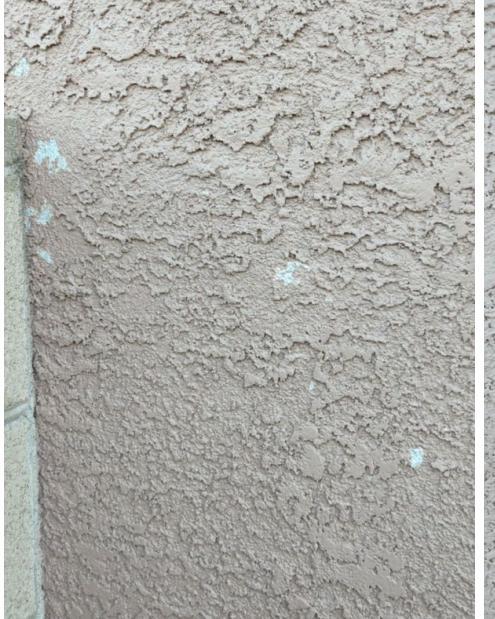
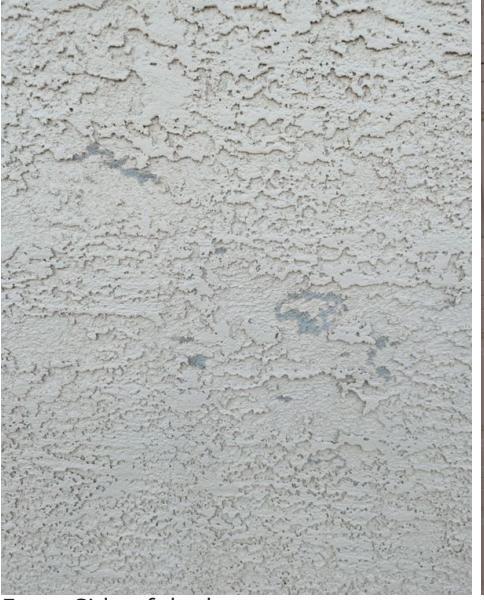
Side of the house

#### 5.7.1 Exterior Paint **DETERIORATED AROUND THE TRIM - TOUCH UPS**

The exterior paint has deteriorated around the trim and siding in some areas. The house is in need of painting touch ups.

Contact a qualified painting contractor.

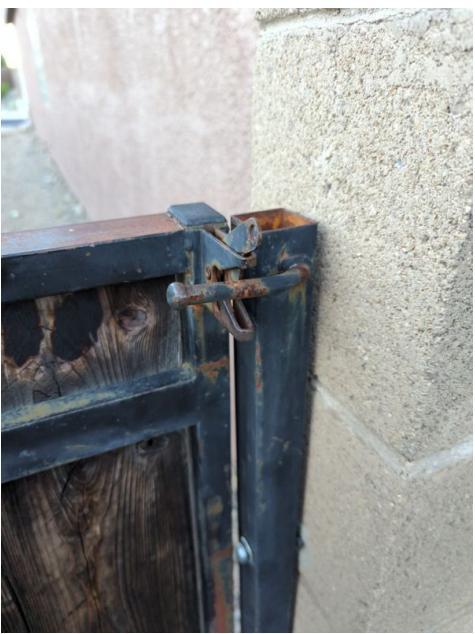
Side of the house

5.9.1 Gates, Fencing, and Walls GATE HARDWARE NEEDS REPAIR/ADJUSTING

The gate hardware is in need of repair/adjusting.

Recommendation Contact a qualified professional. Aaintenance Item

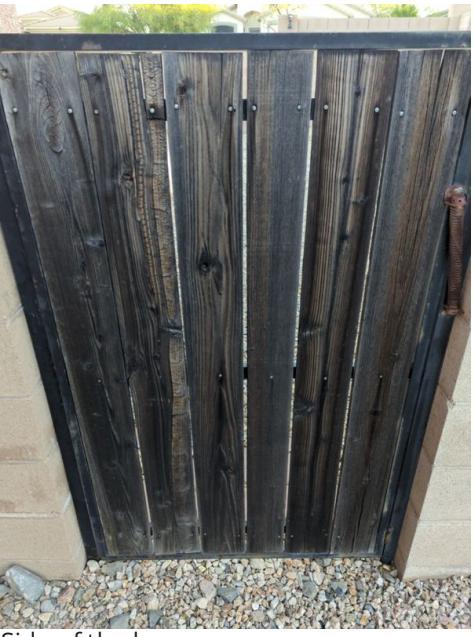
Side of the house

### WOOD DETERIORATION FENCE/GATE

There is wood deterioration observed at the fence and/or gate. Suggest repair or replacement as needed.

Recommendation Contact a qualified professional.

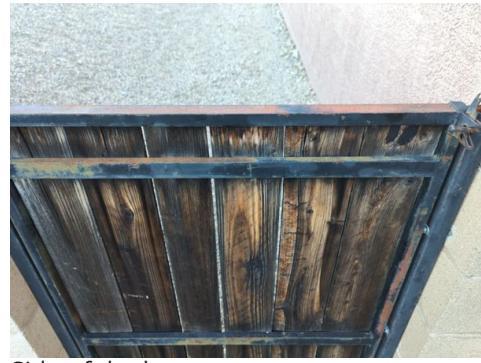
Side of the house

5.9.3 Gates, Fencing, and Walls **GATE IS RUSTED**

The gate is rusted. Recommend repair or replace.

Recommendation Contact a qualified professional.

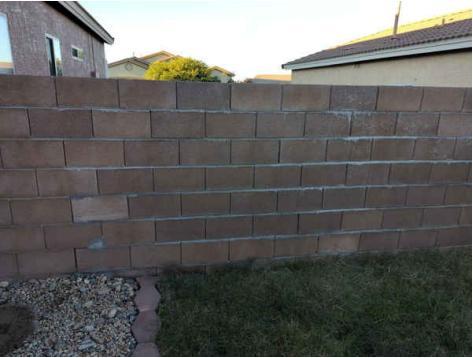
Side of the house

#### **PRIOR REPAIRS**

Prior repairs made to the wall. Recommend further evaluation and possible servicing.

Recommendation Contact a qualified professional.

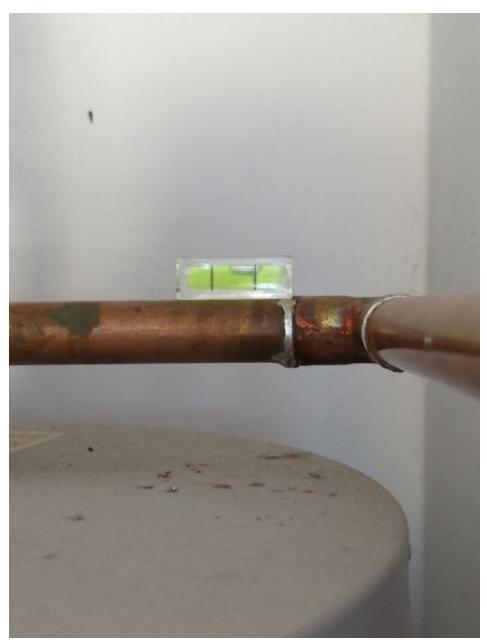
Garage

6.3.1 Automatic Safety Control Condition

The TPR drain line runs "uphill". Recommend repair.

Contact a qualified professional.

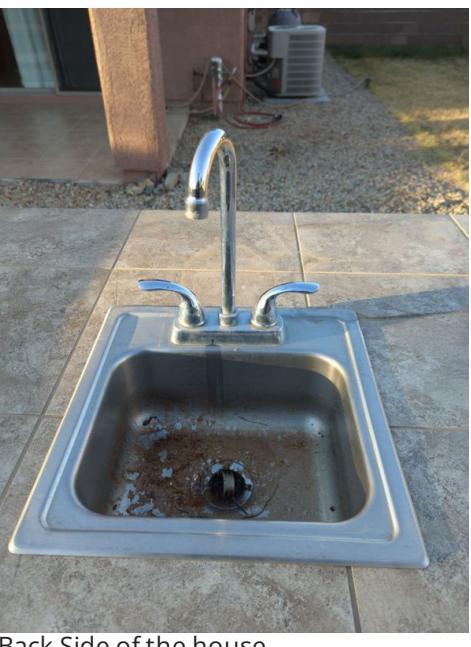
Back Side of the house

7.2.2 Sinks, Fixtures, Faucets, and Valves **FAUCET IS LOOSE** SEE PHOTOS FOR LOCATIONS Opendoor standards issue The faucet is loose. Recommend repair.

Recommendation Contact a qualified professional. Maintenance Item

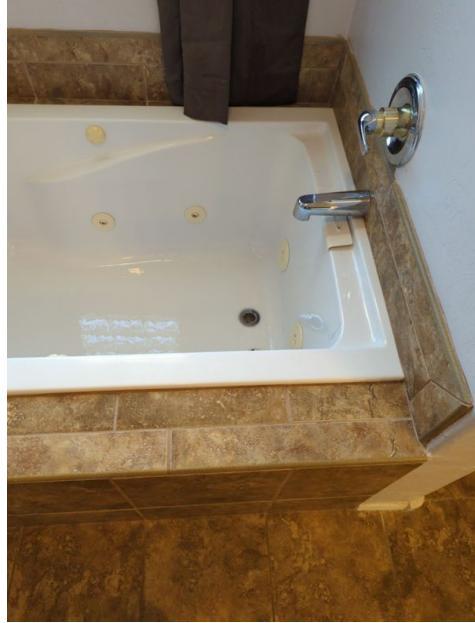
Primary Bathroom

### 7.5.1 Bath Tubs

The drain stopper is inoperable or does not seal properly.

Recommendation Contact a qualified professional.

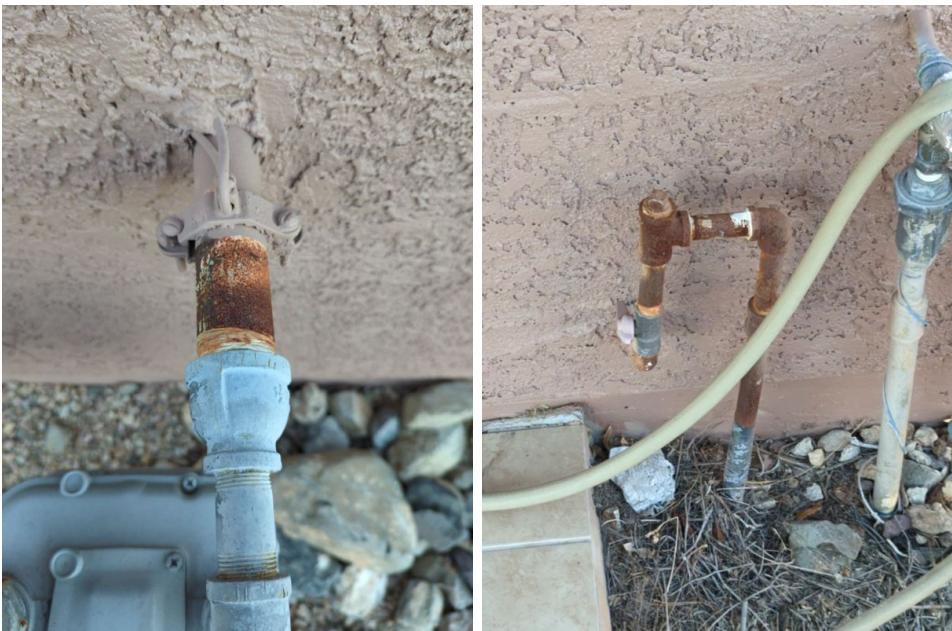
7.13.1 Main Gas Valve & Fuel Plumbing

The gas line is observed to be rusting. Recommend further evaluation and repair as needed.

Recommendation Contact a qualified professional.

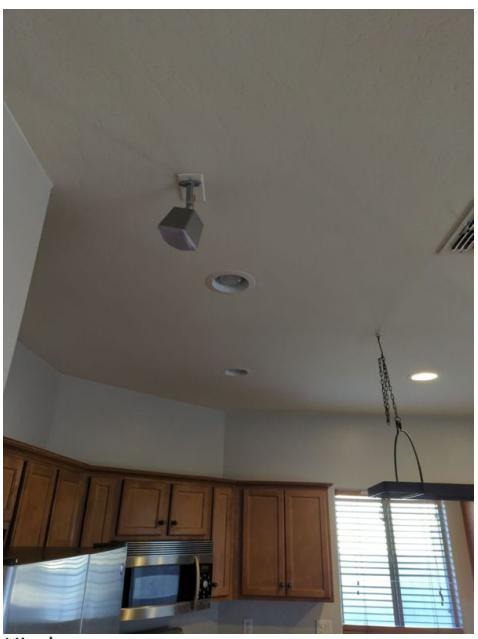
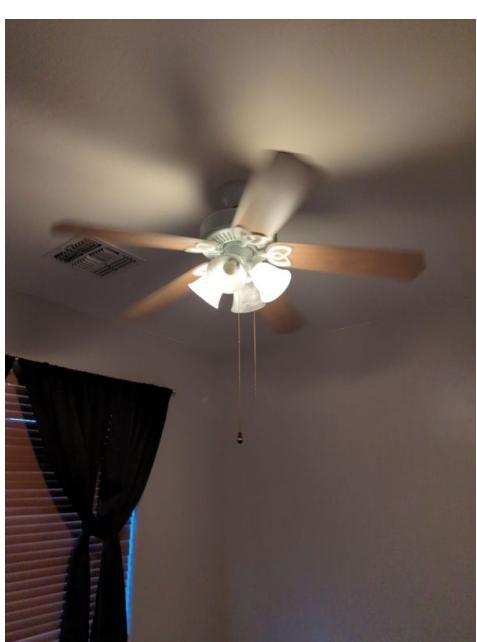
There is a light fixture or bulb that is inoperable. Replace the bulb and test or repair as needed.

Recommendation Contact a qualified professional.

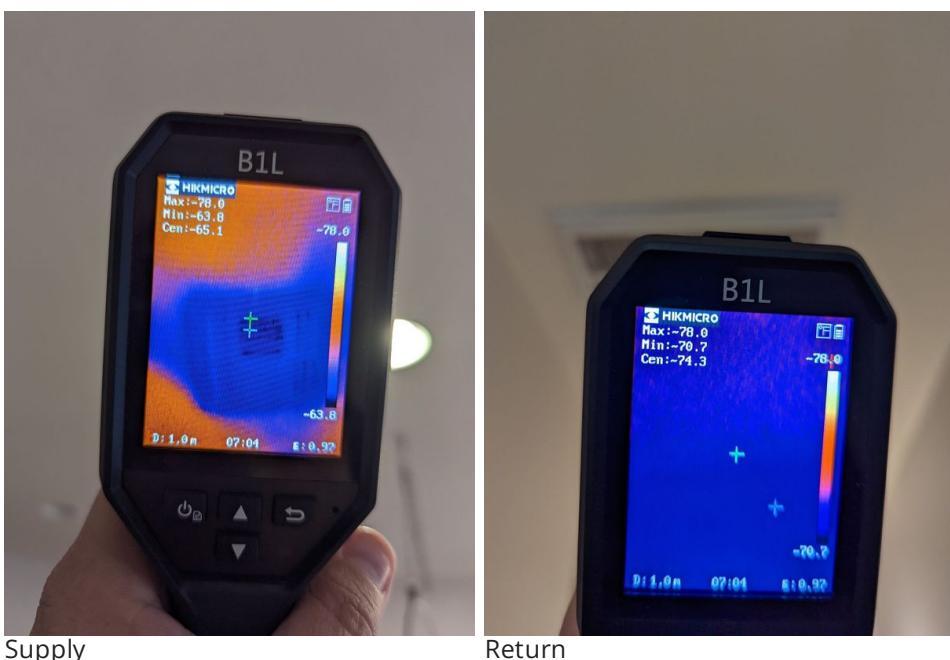
The typical temperature differential split between supply and return air in an air conditioner of this type is 18 to 22 degrees F. This system responded and achieved an inadequate differential temperature. Service is recommended.

Recommendation Contact a gualified professional.

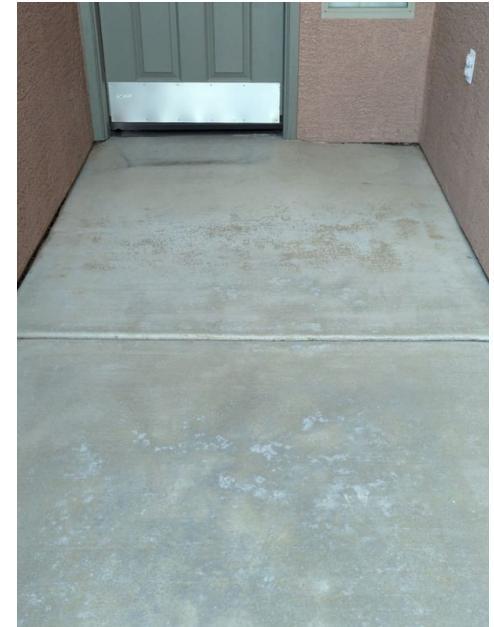
Front Side of the house

The perimeter of the foundation or stem wall is not visible due to the method of construction. Unable to determine the condition of the underlying material.

Contact a qualified professional.

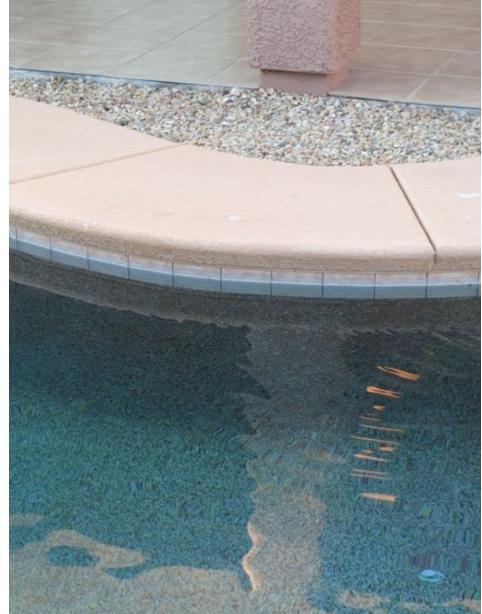
Pool

13.4.1 Coping and Tile Condition **CALCIUM BUILD UP**

There is calcium build up observed on the tiles. Recommend cleaning to prevent permanent damage.

Recommendation Contact a qualified professional.
