# REPAIR REQUEST LIST

1234 Main Street  
02/02/2020 12:50 pm

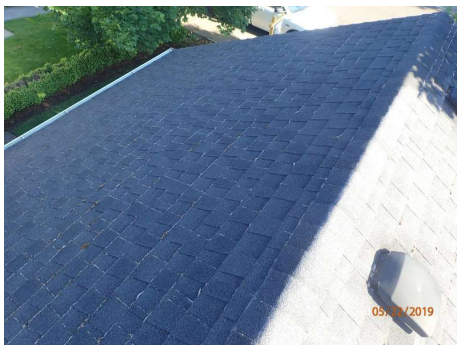
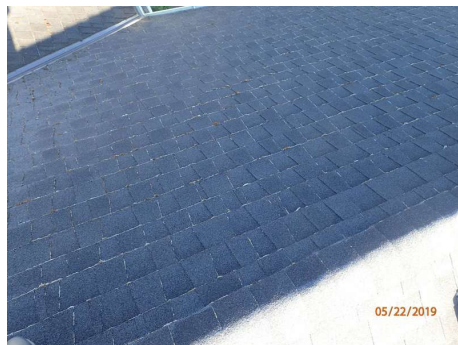
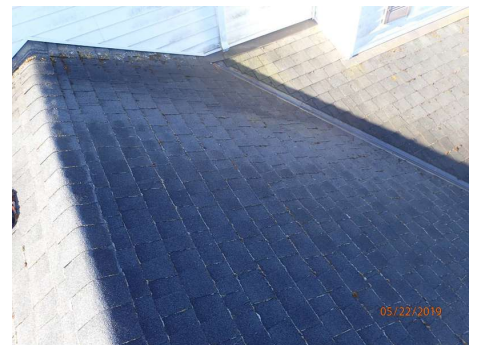
## 2.1.2 - Roof: Coverings MOSS

Moss growth is usually greatest on north-facing roofs, roof areas shaded by trees and other places that are not exposed to enough sun to dry out.

Once established, it acts like a sponge, soaking up and storing rainwater. Some of that water then wicks up under the shingles through capillary action and soaks into and through the roof underlayment, which is typically 15- or 30-pound felt. Eventually, it saturates the roof sheathing below.

Moss can shorten the life span of a shingled roof and result in costly repairs both structural and cosmetic that would not be necessary if the roof were maintained properly and kept clear of moss.

Recommend cleaning and removing any moss from the roof, after which a moss treatment plan can be established to limit future growth. Avoid power washing the moss off because that can drive moisture under the shingles, damaging the underlying roof components. If the roof is to high or steep, recommend contacting a licensed roofing contractor or moss removal specialist.

Recommendation  
Contact a handyman or DIY project

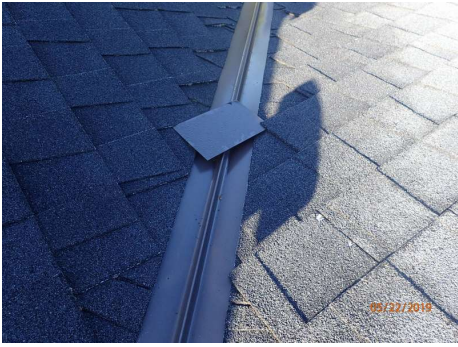
## 2.1.4 - Roof: Coverings DEBRIS - CONSTRUCTION

A piece of flashing was found lodged into the valley. This flashing was not able to be identified from anything necessary in the area and no leaks were noted in the attic. Recommend removing this and monitoring the roof closely as it ages.

Recommendation  
Contact a qualified professional.
