REPAIR REQUEST LIST

1234 Main Street
10/02/2022 11:09 am

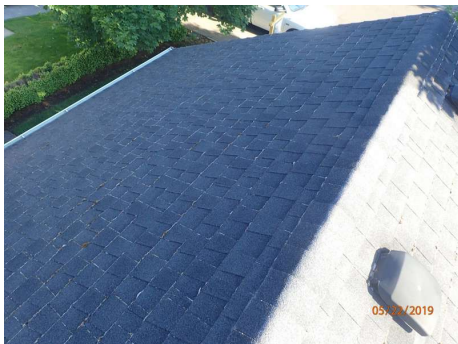
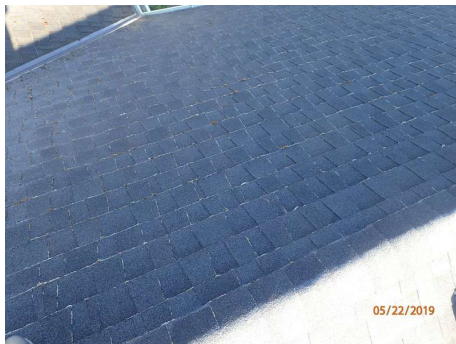
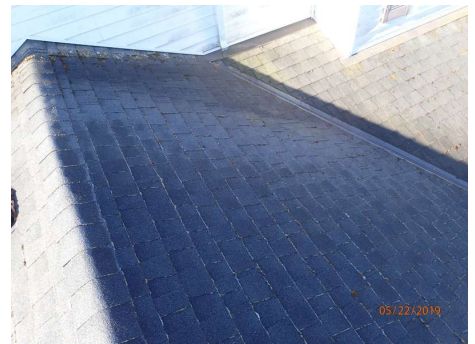
2.1.2 - Roof: Coverings

MOSS

Moss growth is usually greatest on north-facing roofs, roof areas shaded by trees and other places that are not exposed to enough sun to dry out.

Once established, it acts like a sponge, soaking up and storing rainwater. Some of that water then wicks up under the shingles through capillary action and soaks into and through the roof underlayment, which is typically 15- or 30-pound felt. Eventually, it saturates the roof sheathing below.

Moss can shorten the life span of a shingled roof and result in costly repairs both structural and cosmetic that would not be necessary if the roof were maintained properly and kept clear of moss.

Recommend cleaning and removing any moss from the roof, after which a moss treatment plan can be established to limit future growth. Avoid power washing the moss off because that can drive moisture under the shingles, damaging the underlying roof components. If the roof is too high or steep, recommend contacting a licensed roofing contractor or moss removal specialist.

Contact a handyman or DIY project

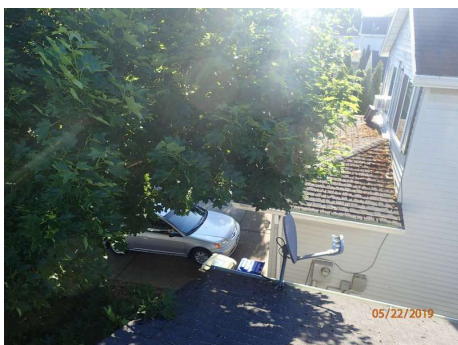
3.8.1 - Exterior: Vegetation, Grading, Drainage & Retaining Walls

TREE OVERHANG

Trees observed overhanging the roof. This can cause damage to the roof and prevent proper drainage. Recommend a qualified tree service trim to allow for proper drainage.

Contact a qualified landscaping contractor

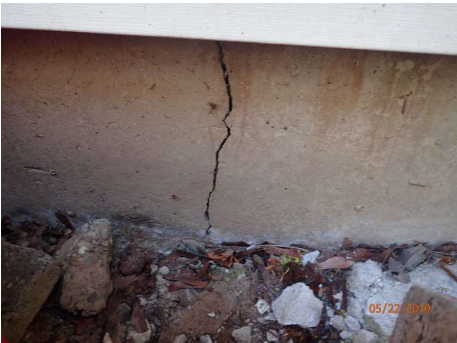
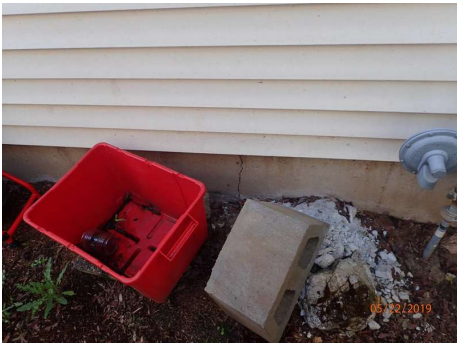
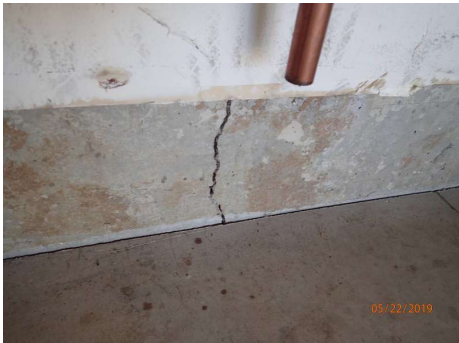
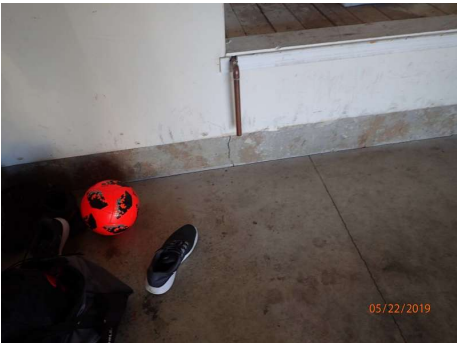
4.1.2 - Basement, Foundation, CrawlSpace & Structure: Foundation
FOUNDATION CRACKS-

Moderate cracking was noted at the foundation in one or more locations. This is common as concrete ages and shrinkage but cracks of this size are generally influenced by additional settling. Recommend monitoring for more serious shifting/displacement.

Location
East Side, Garage

A foundation contractor should be consulted if the crack ever grows.

Recommendation
Recommend monitoring.

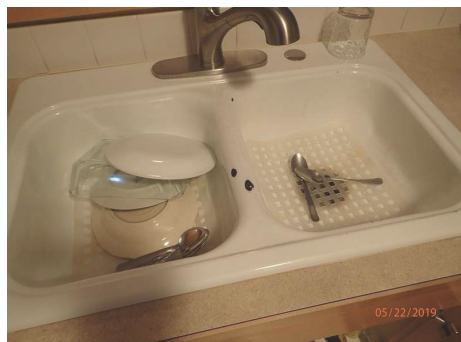
SINK - SURFACE DAMAGE

The sink has surface damage that is cosmetic but could also lead to a potential leak in the future. Recommend replacing the fixture at your own convenience.

Contact a qualified plumbing contractor.

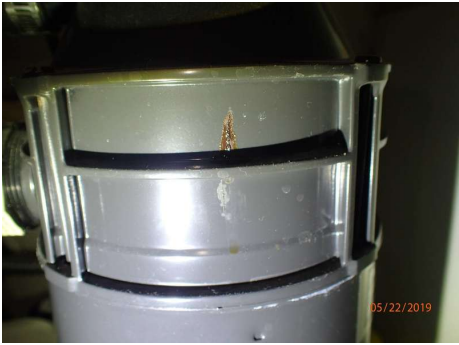
DAMAGED - HOLE/CRACK

A hole/crack was found in the garbage disposal causing a leak. Often times parts can be found to repair this but it tends to be more economical to just replace the unit.
