RE-INSPECTION

614 Chaps Rd SE
RIO RANCHO, NM 87124

Ruben Collado
JULY 6, 2018

This is a re-inspection of systems that were not connected/ turn on at time of original inspection.

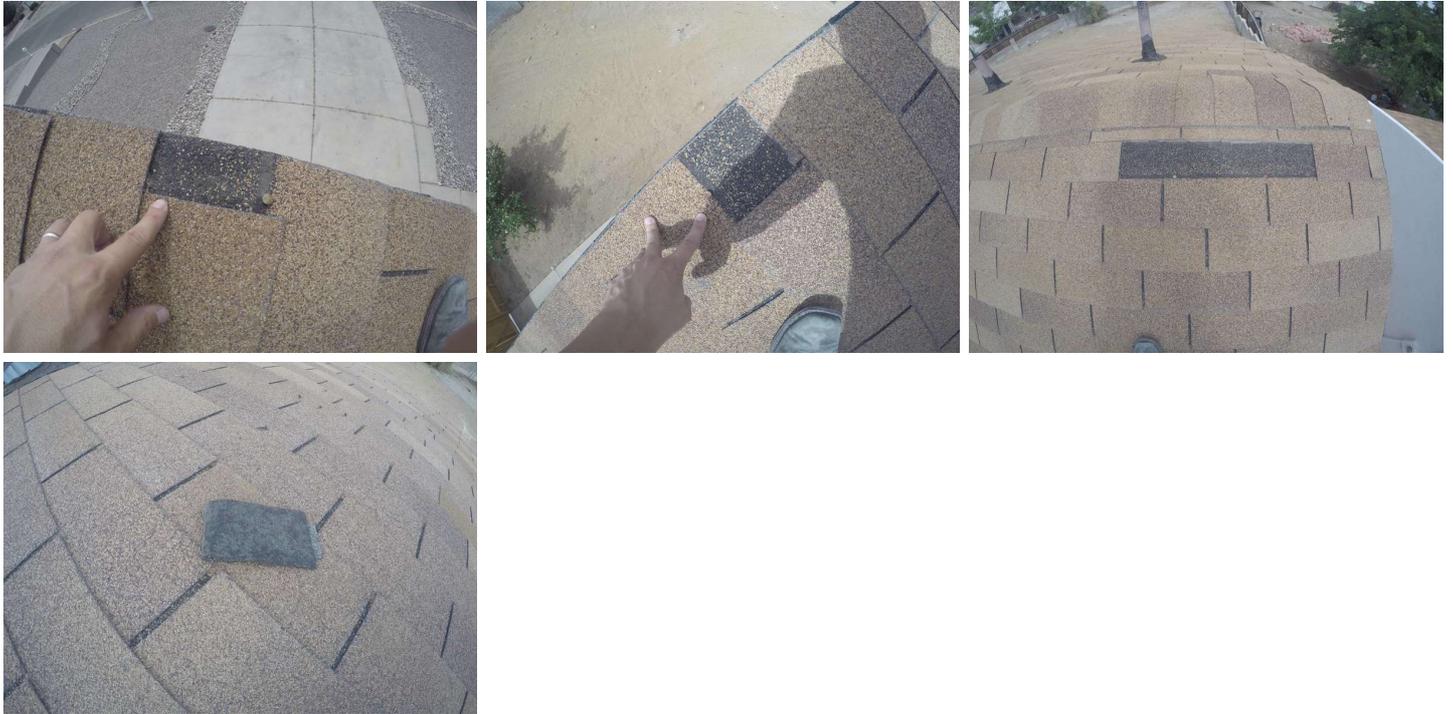
SHINGLES MISSING

Major Concern / Safety Hazard

Observed areas that appeared to be missing sufficient coverings. Recommend qualified roofing contractor evaluate & repair.

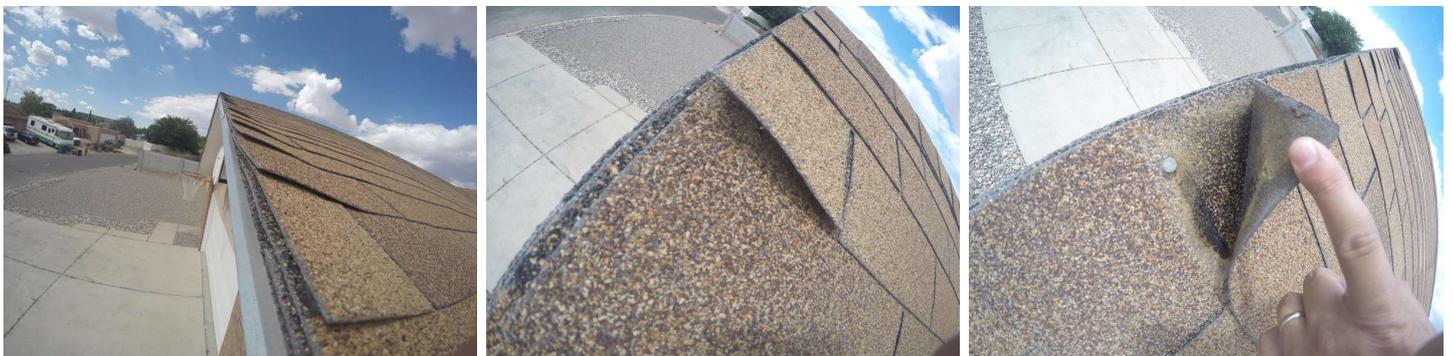
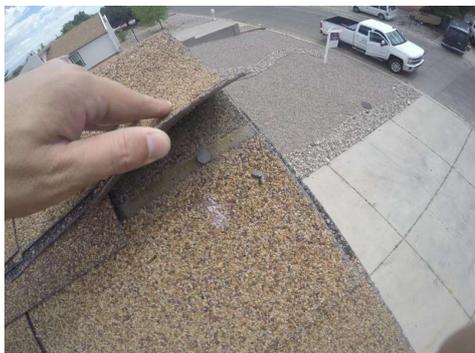
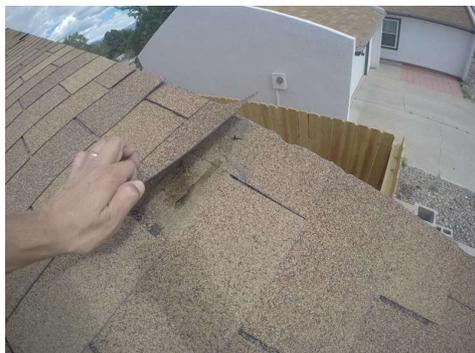
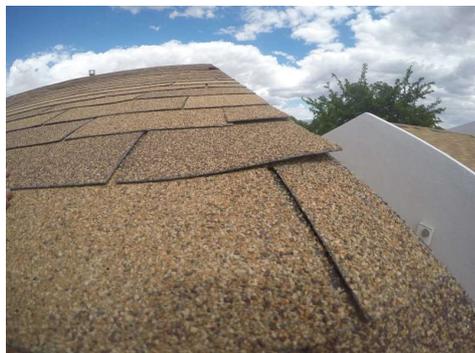
2.2.2 Coverings

UNSEALED/LIFTED SHINGLES

Major Concern / Safety Hazard

Observed a large number of tabs that were unsealed. This may be a result of under-driven nails, debris, wind-driven damage or other factors. Recommend a qualified roofing professional evaluate and make recommendations.

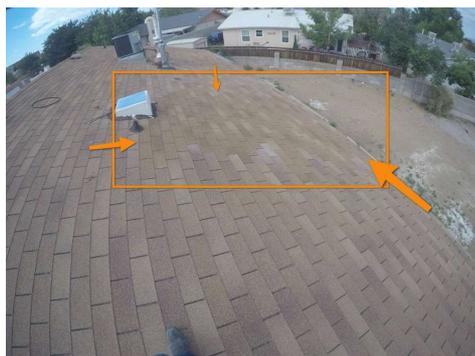
2.2.3 Coverings

PREVIOUS REPAIR

Evidence of previous repair to shingles was apparent. Recommend asking seller if repair work was performed and why.

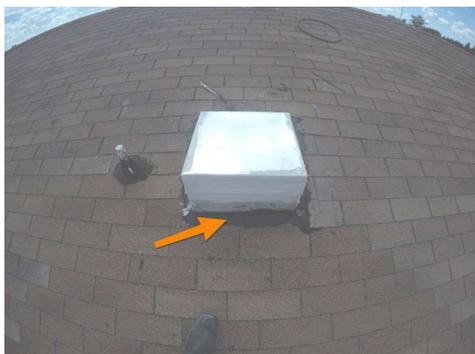
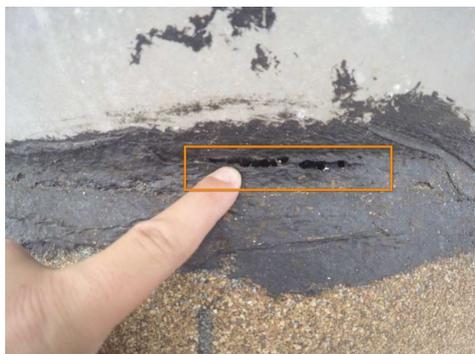
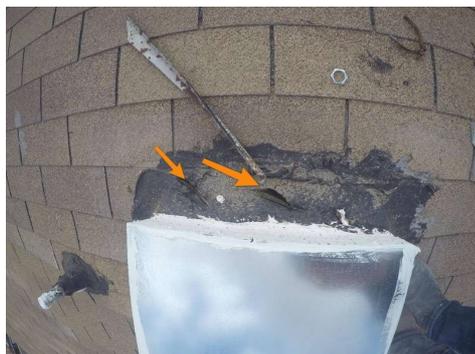
2.4.1 Flashings

LOOSE/SEPARATED

Flashings observed to be loose or separated, which can lead to water intrusion and/or mold. Recommend a qualified roofing contractor repair.

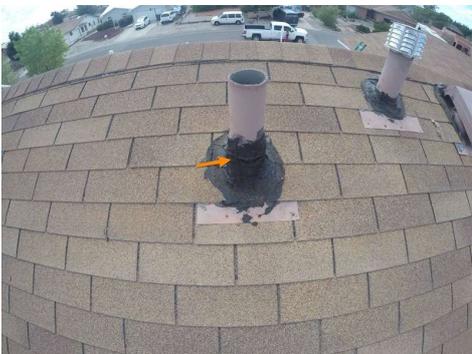
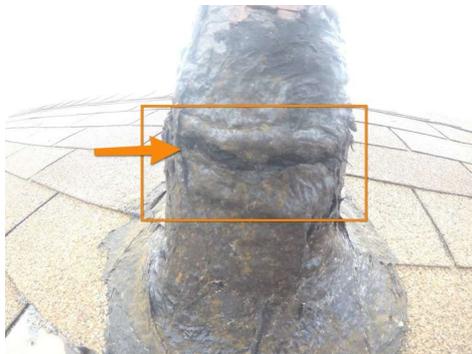
Pipe flashing rubber boot was damaged which could allow moisture into the home, recommend repair.

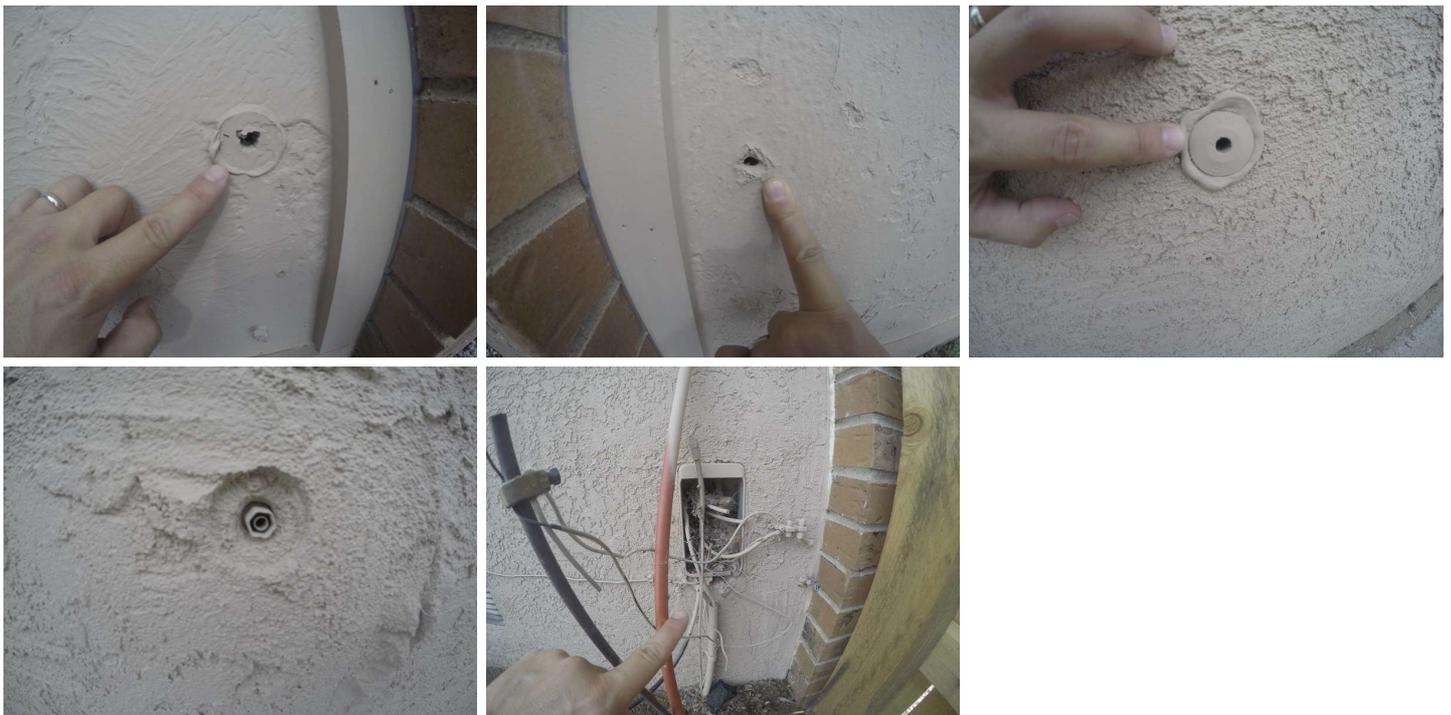
3.1.1 Siding, Flashing & Trim

There is opening, gap or hole in siding which should be repaired. This can allow water intrusion and rodent infestation as well as deterioration of the surrounding material.

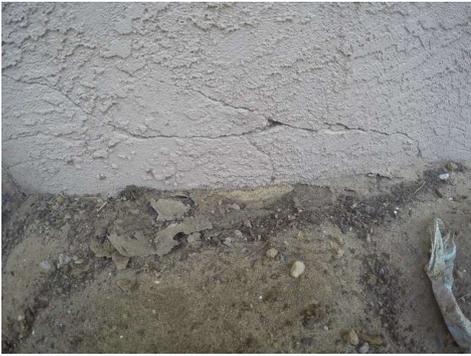
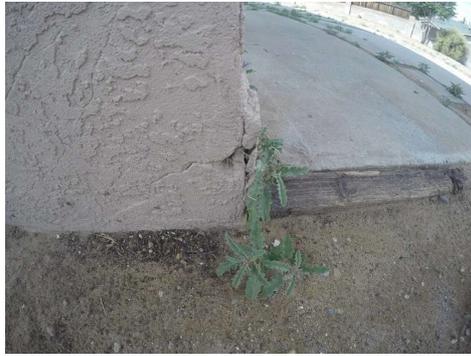
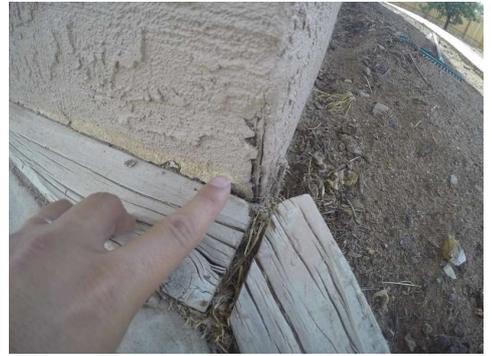
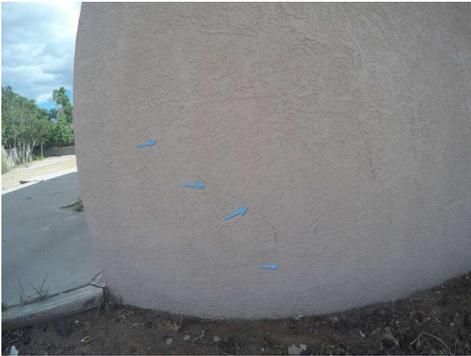
3.1.2 Siding, Flashing & Trim

STUCCO CRACKING - MINOR

Siding showed cracking in one or more places. This can be a result of temperature changes, and typical as homes with stucco age. Recommend monitoring.

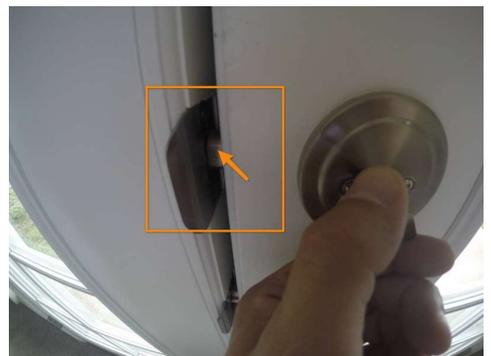
Door does not close or latch properly. Recommend qualified handyman adjust strike plate and/or lock. Here is a DIY troubleshooting article on fixing door issues.

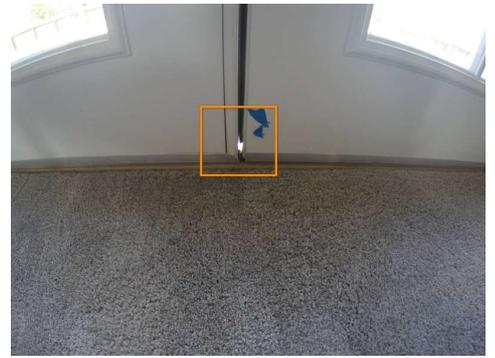
3.2.2 Exterior Doors

WEATHERSTRIPPING NEEDS REPAIR

Door weatherstripping is in need of repair/replace. This can result in significant energy loss and moisture intrusion. Recommend repair/replacement of standard weatherstripping. Here is a DIY guide on weatherstripping.

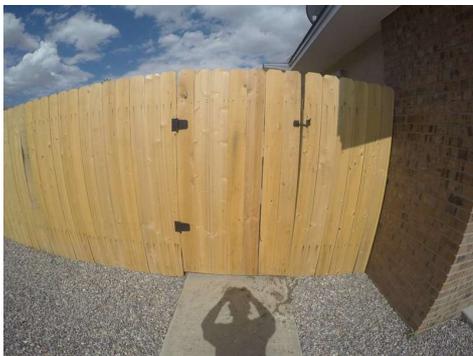
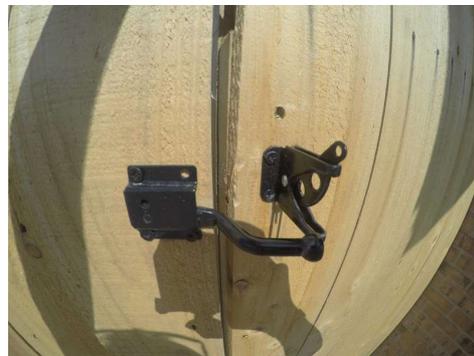
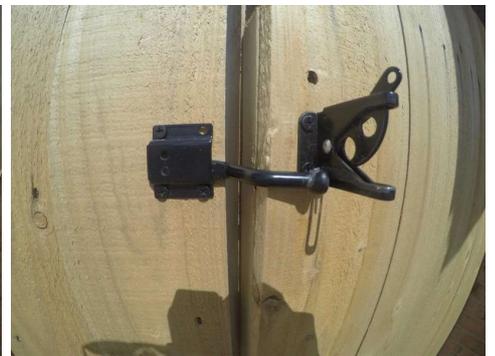
GATE DOES NOT LATCH

The gate to the side yard does not latch. Recommend repairing to ensure access is secured.

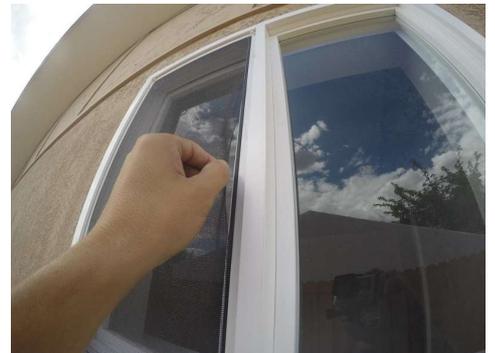
3.3.1 Windows

SCREEN DAMAGED.

Window screen damaged. Recommend repairing screen to keep insects and pests out of house.

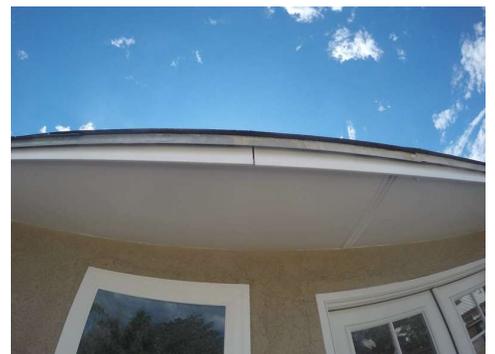
3.6.1 Eaves, Soffits & Fascia

GAP

There is opening, gap or hole in fascia / soffit which should be repaired. This can allow water intrusion and rodent infestation as well as deterioration of the surrounding material.

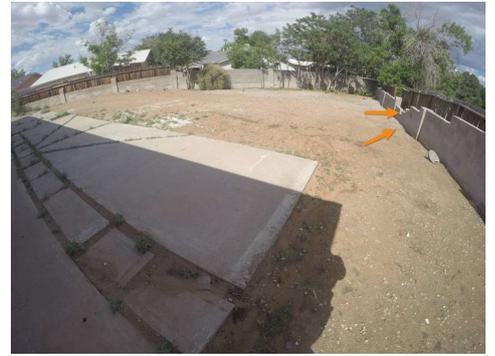
3.7.1 Vegetation, Grading,
Drainage & Retaining Walls

Block wall was not securely fastened. Loose blocks can fall and cause injury.

Recommend repair by qualified contractor.

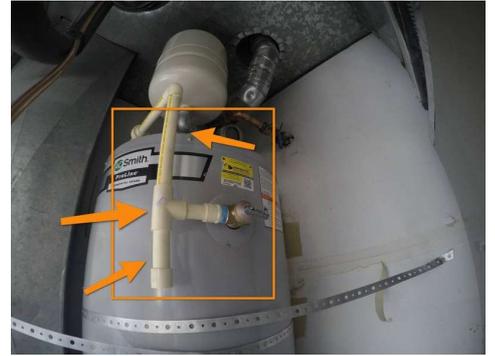
Recommend a plumbing professional repair or replace.

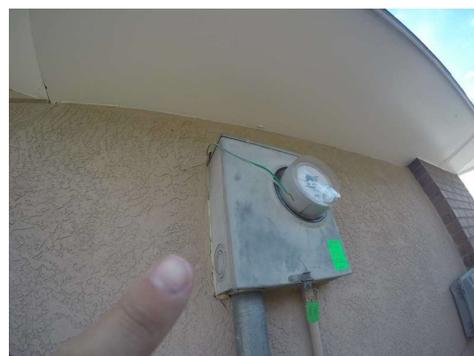
8.2.1 Service Entrance Conductors

Ungrounded ground wire sticking out from meter.

Recommend a qualified professional to investigate and repair.

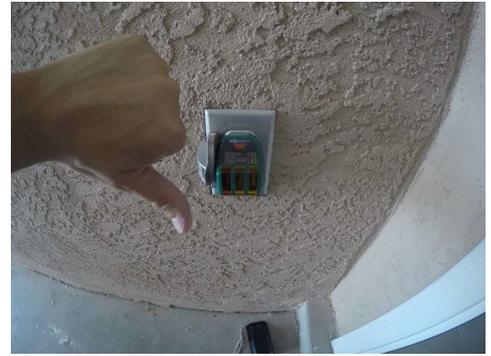
8.5.1 Lighting Fixtures, Switches & Receptacles

FRONT EXTERIOR ENTRYWAY

Receptacle was not working at the time of inspection, recommend repair.

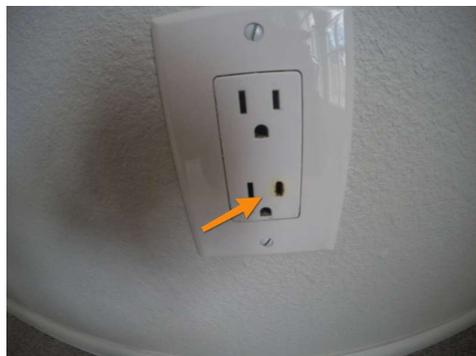
8.5.2 Lighting Fixtures, Switches & Receptacles

RECEPTACLE SCORCHED/BURN MARKS

Receptacle contained burn/scorch marks. This can be an indication that an electrical hazard occurred or may occur again in the future. Recommend review.

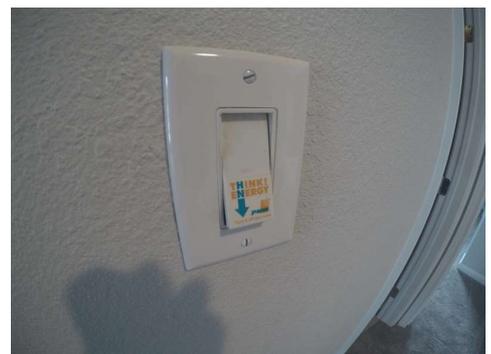
SWITCH BROKEN

Broken light switch, recommend repair.

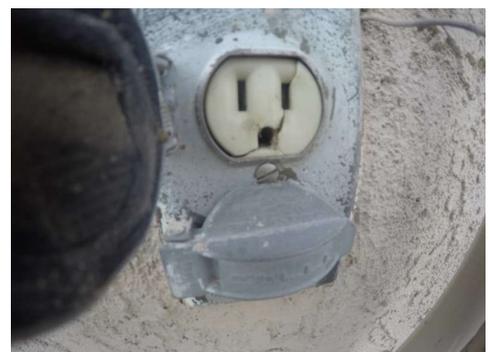
8.5.4 Lighting Fixtures, Switches & Receptacles

RECEPTACLE DAMAGED

BACK YARD WALL OF HOUSE

Receptacle damaged. Recommend replacement by qualified professional.

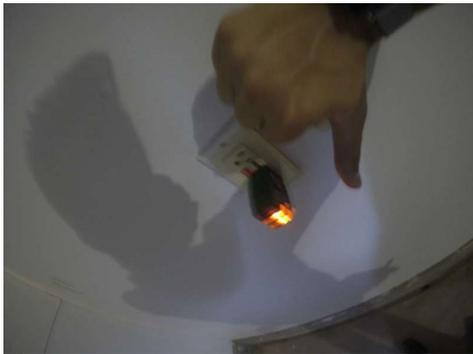
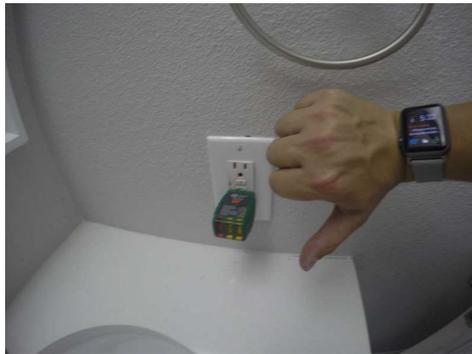
GFCI NOT OPERABLE

GFCI Receptacle was not responding to the test/reset button when pressed. Recommend qualified professional review and repair as necessary.

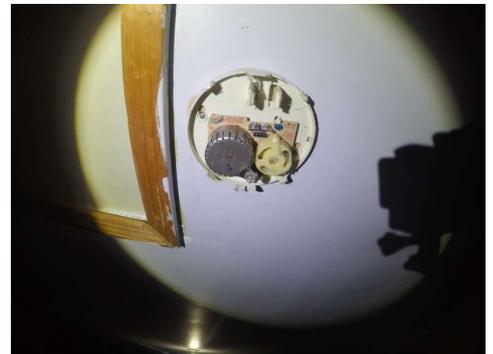
8.7.1 Smoke Detectors

NEEDS REPLACED

GARAGE

Recommend smoke detector that is older than 10 years of age or if age is unknown, replace with new smoke detector.

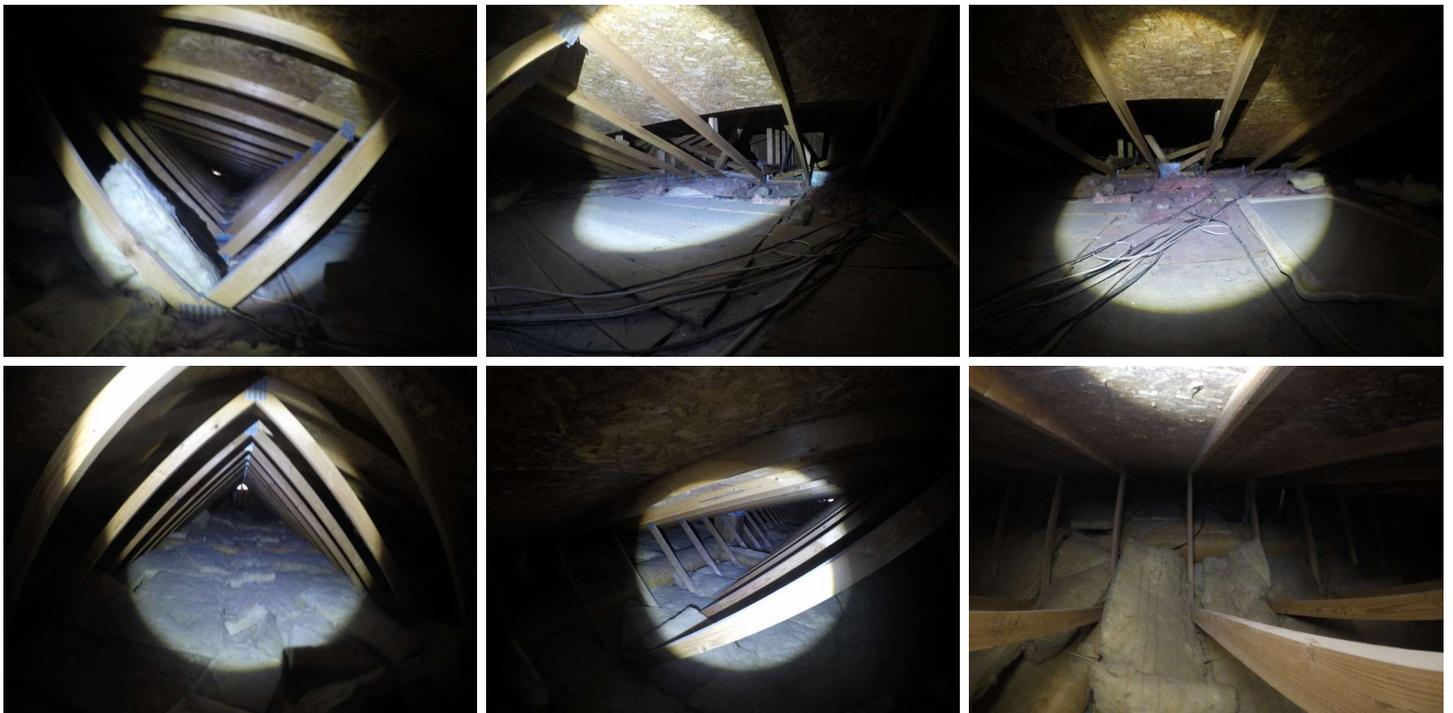
ACCESS RESTRICTED

Access was restricted due to attic height and lack of walkway. Inspected from the access.

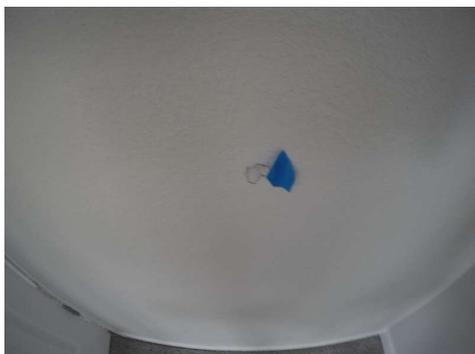
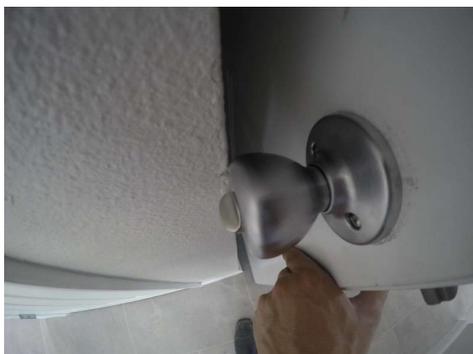
DOORKNOB HOLE

Wall had damage from doorknob. Recommend a qualified handyman or drywall contractor repair.

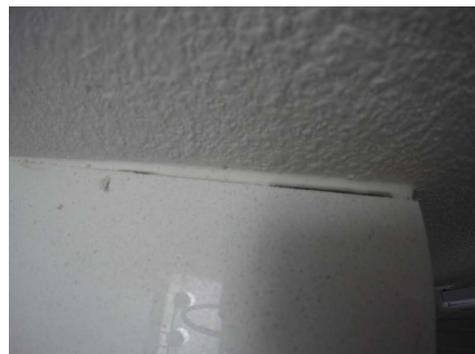
10.5.1 Countertops & Cabinets

POOR/MISSING CAULK

Bathroom countertop was missing sufficient caulk/sealant at the wall. This can lead to water damage. Recommend adding sealant at sides and corners where counters touch walls.

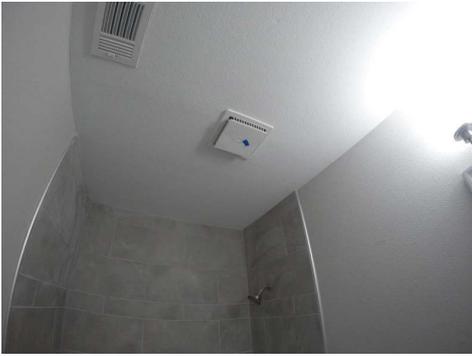
Hall Bathroom exhaust vent emits screech when operated by switch.

Recommend repair or replacement by qualified professional.

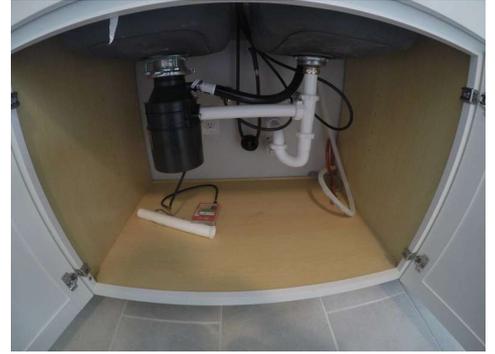
GARBAGE DISPOSAL WIRING

The electrical cable for the garbage disposal at the kitchen should be protected in a flexible metal conduit. This will help prevent damage to the wire from items being moved under the kitchen sink.

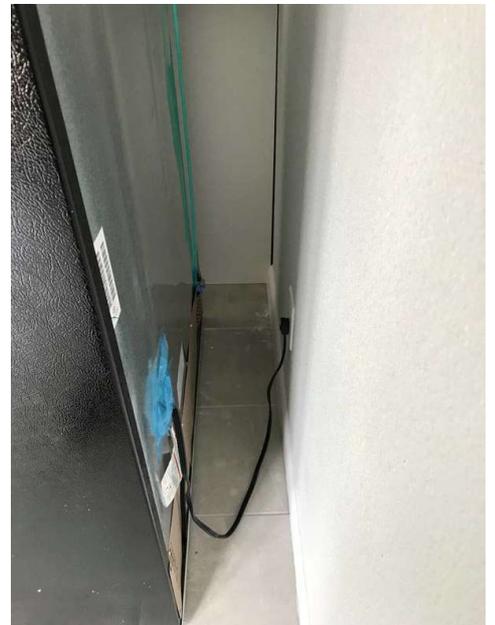
While the refrigerator features an ice maker and water dispenser, there is no water line hooked up to the refrigerator.

If these features are desired, a water line will need to be installed.

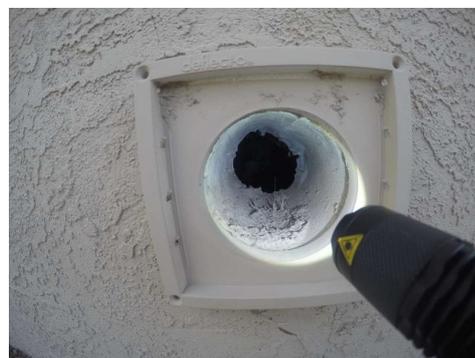
Recommend that a dryer vent louvered hood be installed outside. This can prevent rodents and other pests from entering the dryer vent and causing damage.

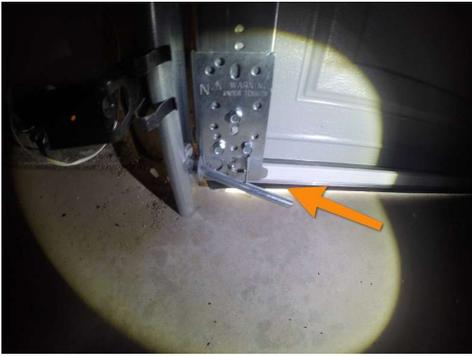
BROKEN HARDWARE

Broken wheel on door roller hardware, recommend repair.

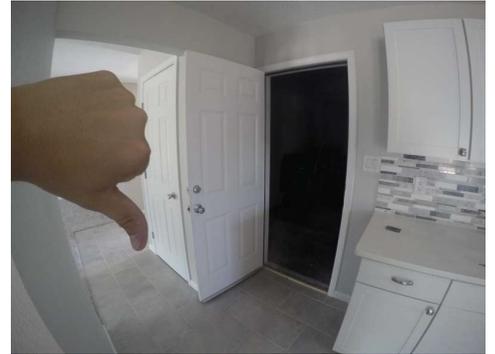
14.11.1 Occupant Door (From garage to inside of home)

NOT SELF-CLOSING

Door from garage to home should have self-closing hinges to help prevent spread of a fire to living space. Recommend a qualified contractor install self-closing hinges.
