BEST HOME INSPECTIONS

SAMPLE REPORT

1234 Main St Denver, CO 80210

AUGUST 27, 2022

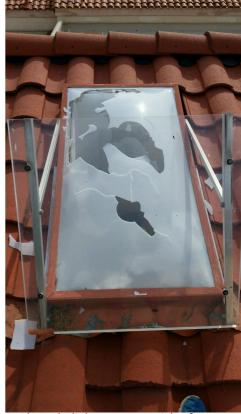
4.4.1 Skylights, Chimneys & Roof Penetrations

SKYLIGHT CRACKED

Skylight was cracked in one or more places. Recommend a qualified roofing contractor repair.

Broken skylight presents risk of water entry and glass shards entering house.

Recommendation

Contact a qualified roofing professional.
