IDAHO SKY
208.267.0540
netmail@idahosky.com
<https://www.idahosky.com>

ROOM-BY-ROOM RESIDENTIAL DEMO

1234 Demonstration Report 1
Bonners Ferry ID 83805

Mr Anderson
NOVEMBER 17, 2021

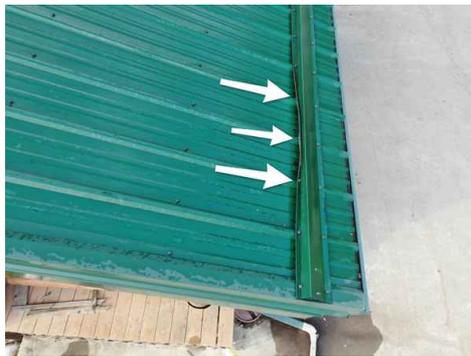
Missing / Popped Screws

LOOSE AND MISSING SCREWS/NAILS

Observed one or more under-driven nails/fasteners. Recommend a qualified roofing contractor evaluate and repair.

There are small holes in the roof where screws are missing.

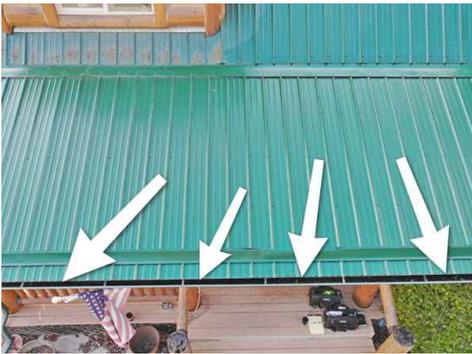
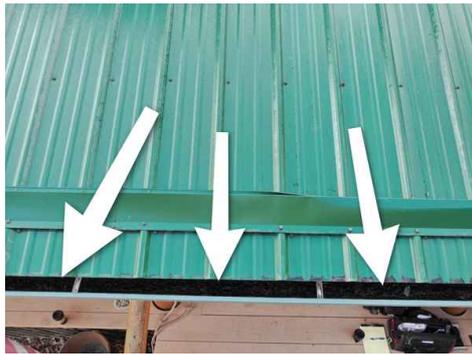
Debris has accumulated in the gutters on the north side of the house. We recommend cleaning to facilitate water flow.

Contact a qualified gutter contractor

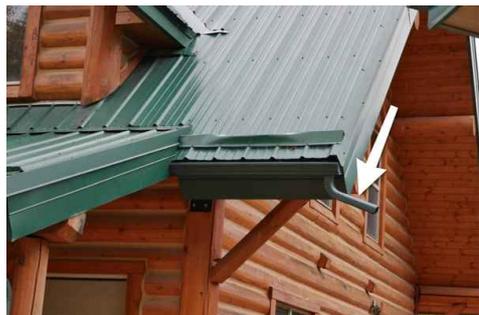
North West Gutter

DOWNSPOUTS DRAIN NEAR HOUSE

One or more downspouts drain too close to the home's foundation. This can result in excessive moisture in the soil at the foundation, which can lead to foundation/structural movement. Recommend a qualified contractor adjust downspout extensions to drain at least 3 feet from the foundation.

Contact a qualified gutter contractor

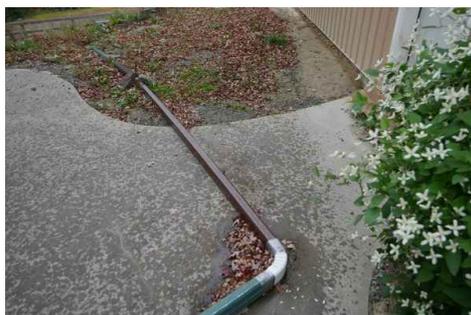
North West Gutter Drain

GUTTER DAMAGED

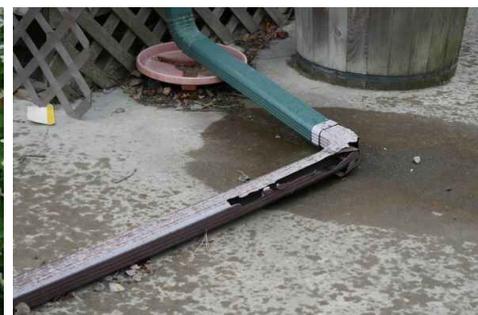
North East Gutter Drain Damaged

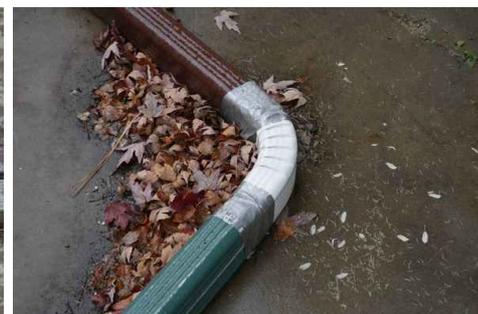
North West Gutter Drain Taped Together

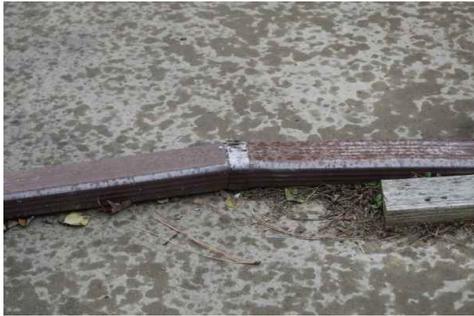
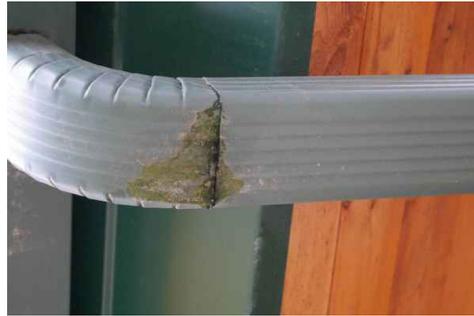
GUTTER LEAKAGE

Contact a qualified roofing professional.

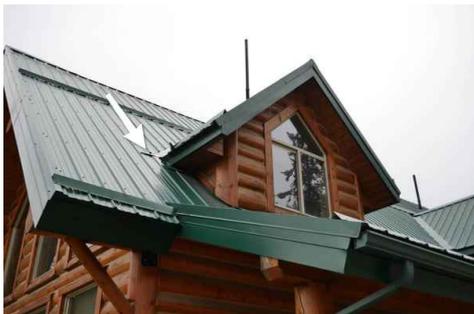
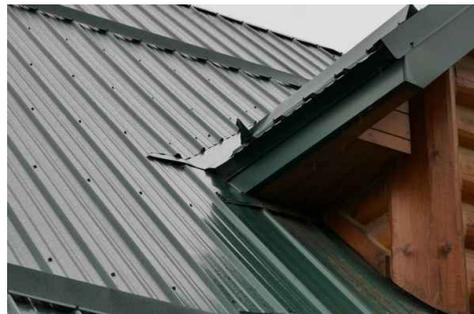
ROOF FLASHINGS

Roof flashing by the gable is detaching from the roof. Evaluation and repair recommended by a qualified professional.

Contact a qualified professional.

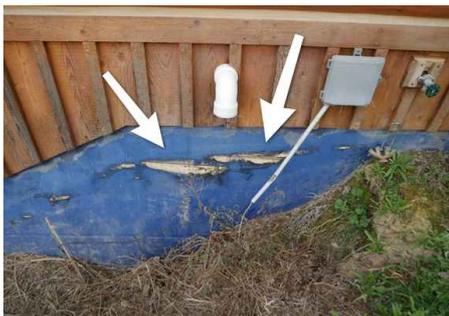
East Side of the Foundation

The protective wrapping is torn on east side of the house.

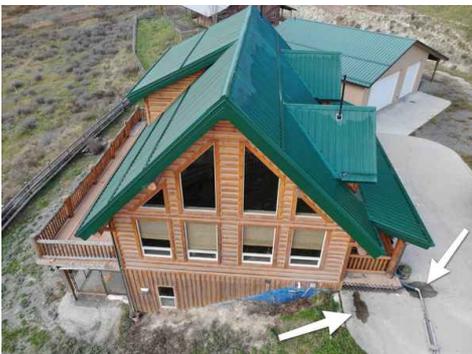
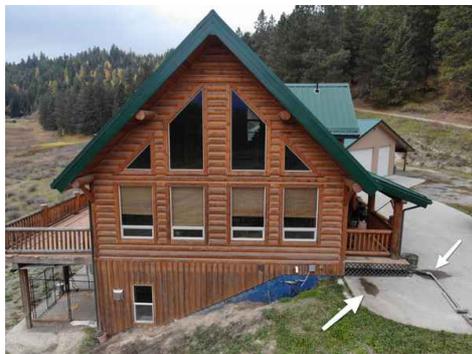
The concrete on the left side of the porch has a crack/split.

Moisture is draining to and collecting in this crack, when it rains.

This can cause moisture to penetrate underneath. If enough moisture collects and freezes, it can cause the concrete to swell and crack even more.

Additionally, the gutter on the ground is leaking moisture. that moisture is draining under the porch.

Recommend monitor and/or patch/seal.

Contact a qualified concrete contractor.

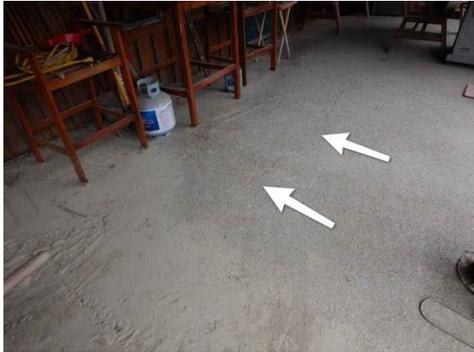
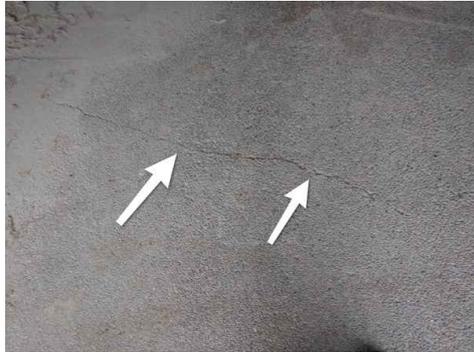
Basement concrete has signs of minor cracking.
The concrete has a noticeable hump. This hump could be caused by frost heave, or water.
Evaluation and repair by a qualified contractor recommended.

Concrete Cracks

Recommendation
Contact a qualified professional.

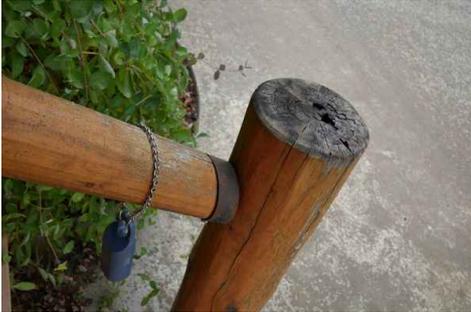
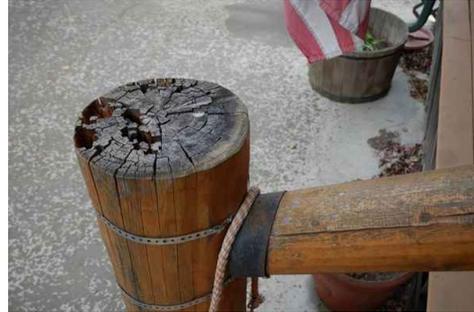
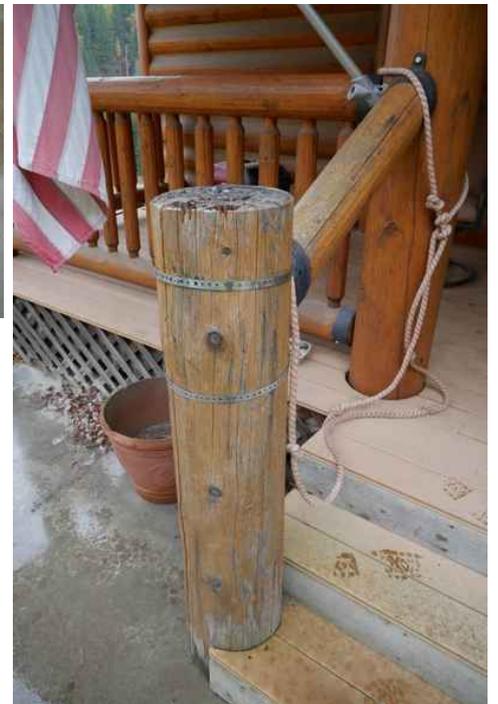
The front porch posts are rotted out.
Repair recommended.

Front Steps Post

Contact a qualified professional.

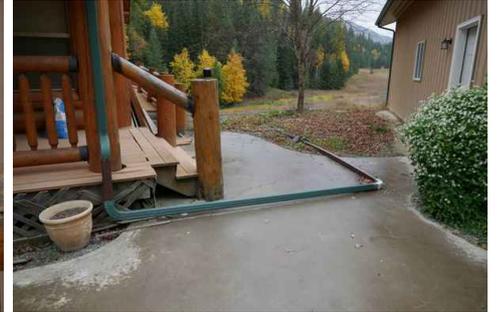
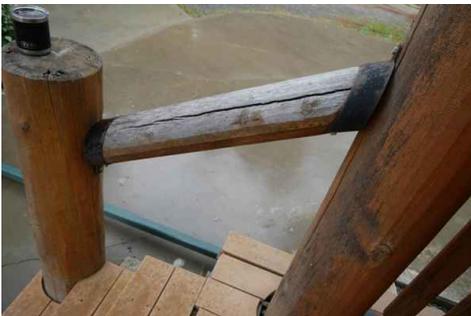
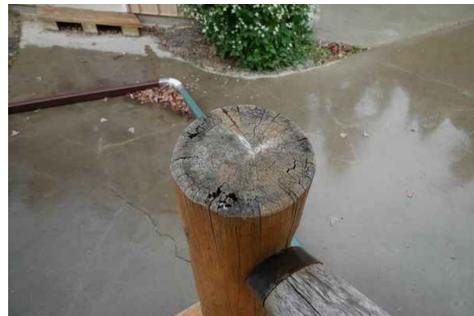
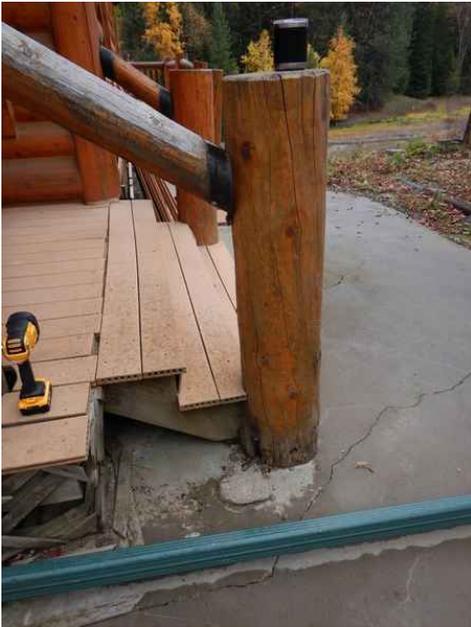
Side Steps Post

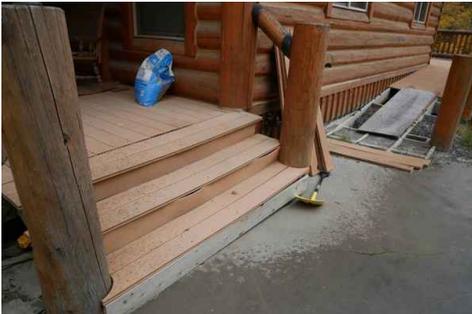
Steps Location

The steps on the front porch have warped Trex boards, some boards are detaching from steps. Repair recommended.

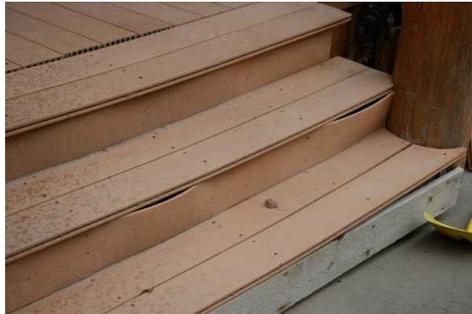
Warped Boards

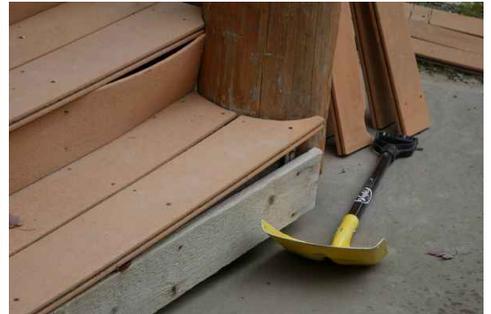
Board Detaching From the Step

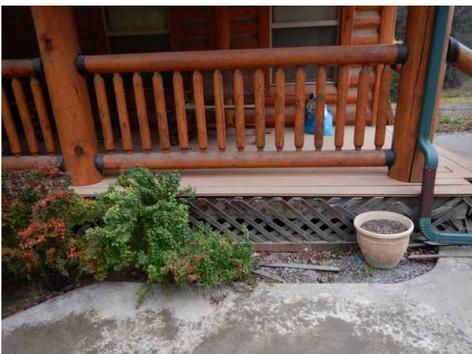
Front Porch Lattice

The front porch lattice is broken in some spots, and is detaching from the porch framing.

Repair recommended.

Contact a qualified professional.

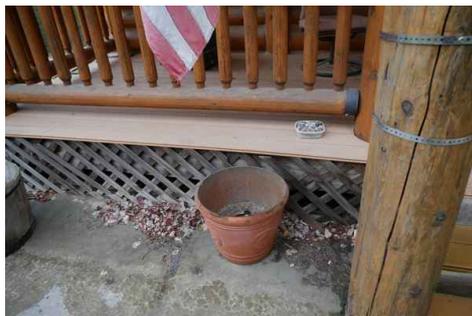
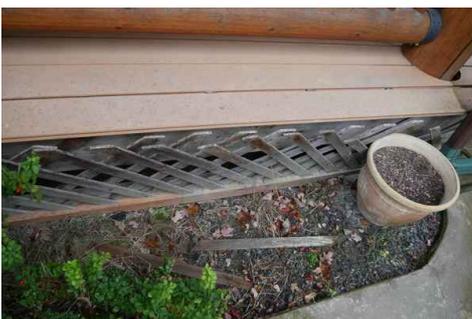
Detached Lattice

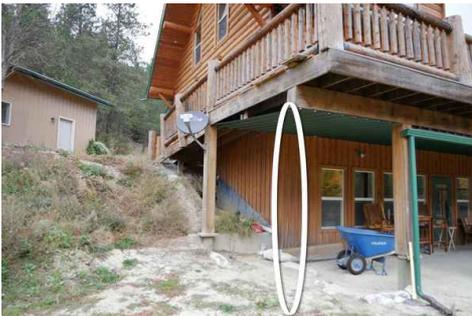
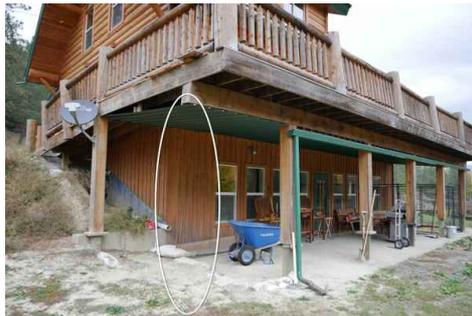
1: The South West Post that is supposed to be holding up the entire corner of the deck, is missing. It appears to be built as a possible cantilever. However, it is insufficient.

Missing Corner Support Post

The entire deck needs to be replaced. It is a major safety hazard.

Contact a qualified deck contractor.

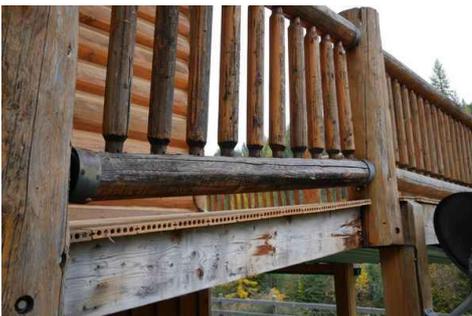
4: The flooring on the deck is made with 1st generation Trex. This material is unsafe, and should be replaced throughout with a different material. The current deck floor boards are not properly fastened. There are many loose and unfastened boards. A person could easily fall through the deck floor.

Deck Railing and Trex

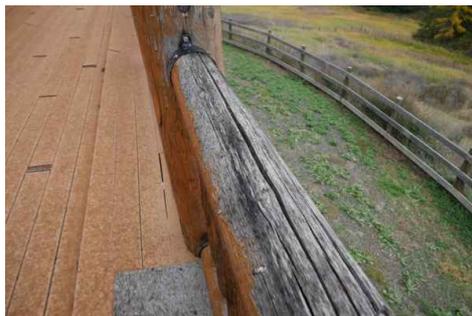
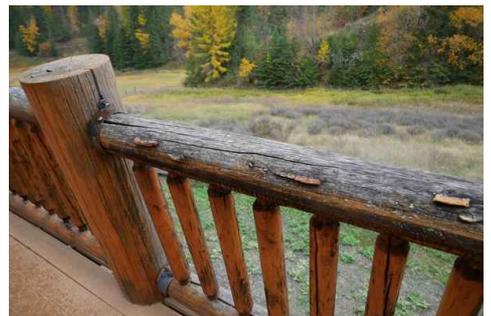
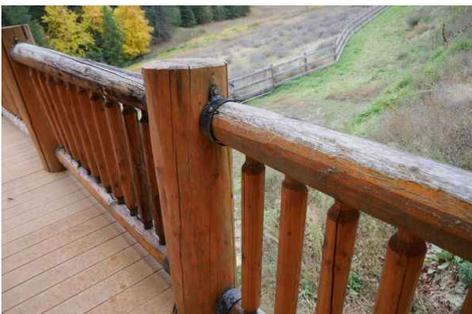
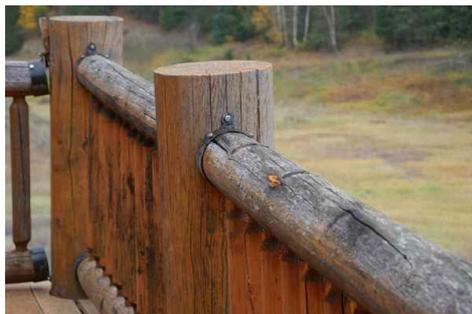
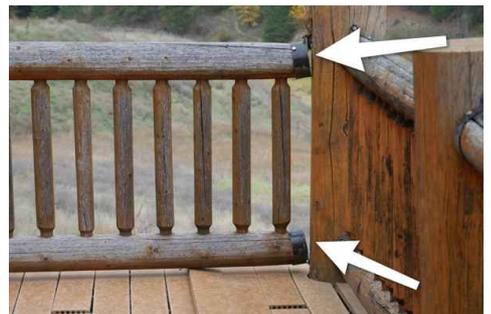
3: The railing is not connected properly at the corners. If someone leans against the railing, it can easily break away due to rot, and/or being disconnected.

Railing Corners are Detached

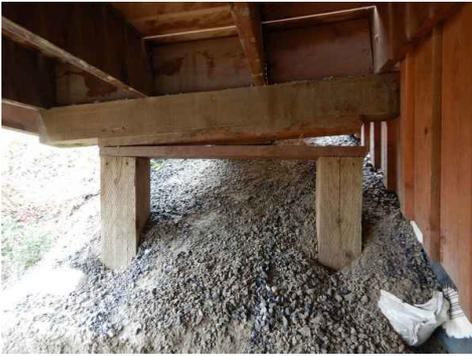
Underneath Ramp Entrance

Additionally, the deck entrance ramp has structural failures underneath. There is a single brick holding it up. (see photo)

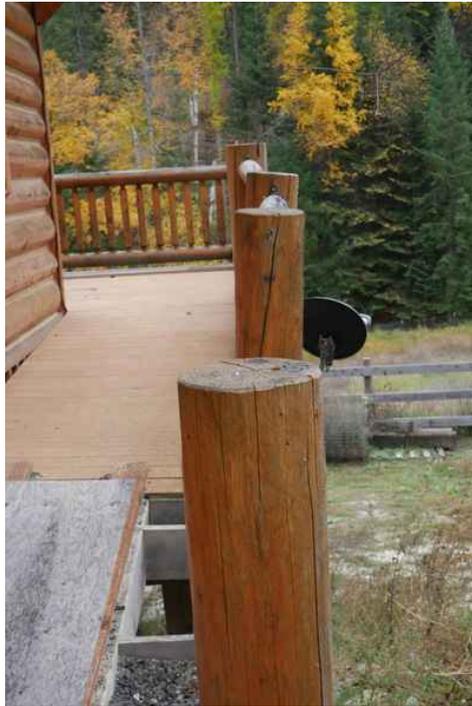
Deck Entrance Ramp Dangerous

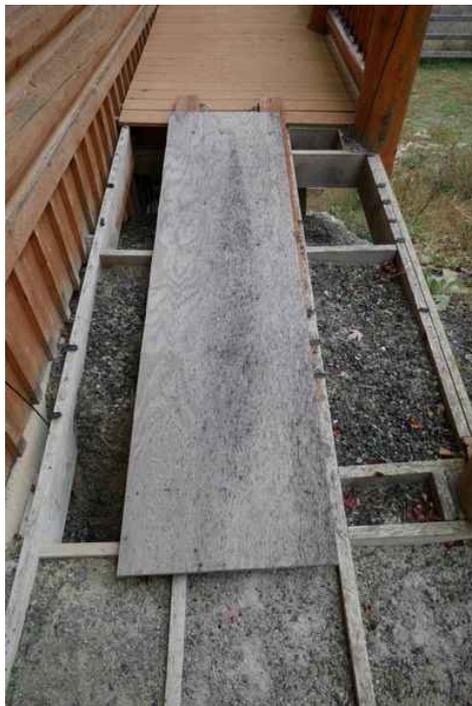
Deck Entrance Ramp Disassembled

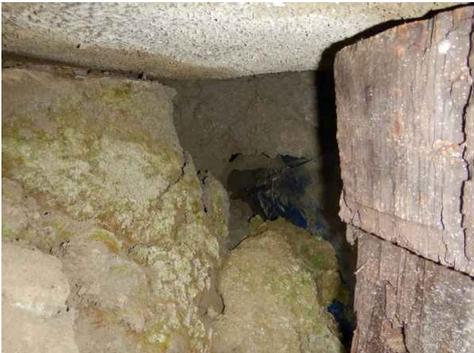
Water and earth erosion was discovered under the deck ramp close to the house foundation. It creates a mud slide that can enter the house which can also create mold problems.

Water Erosion Under the Deck Ramp

It is recommended to remediate the erosion issues.

Contact a qualified professional.

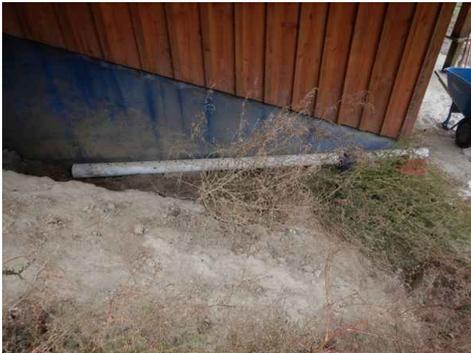
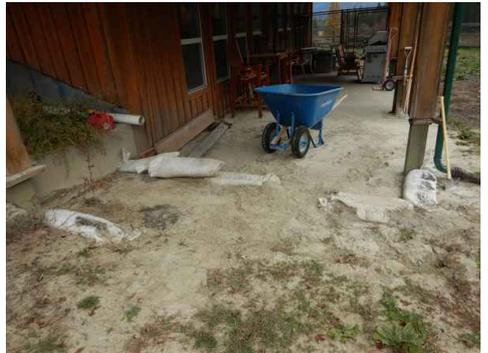
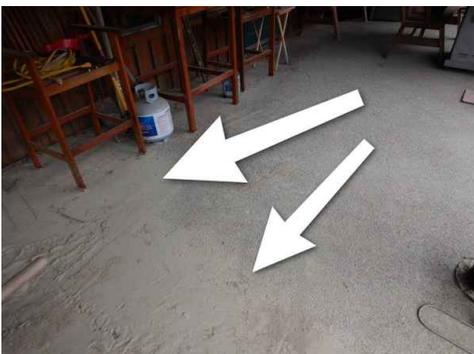
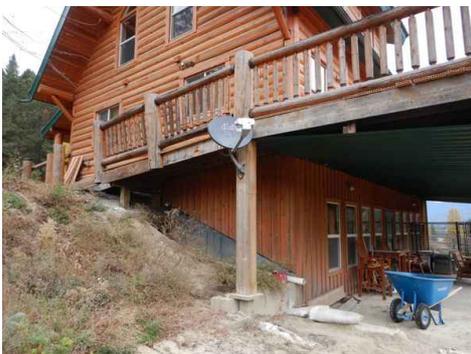
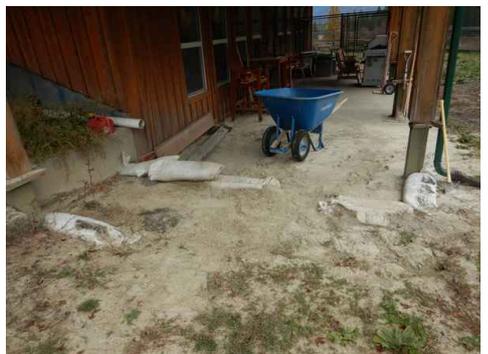
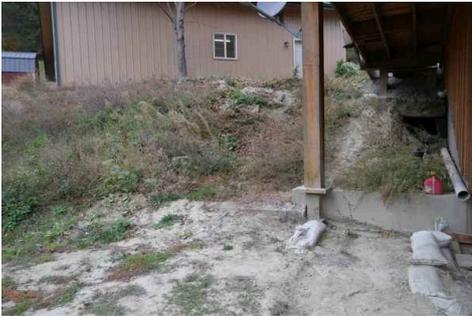
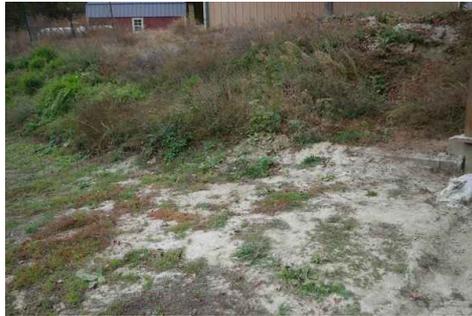
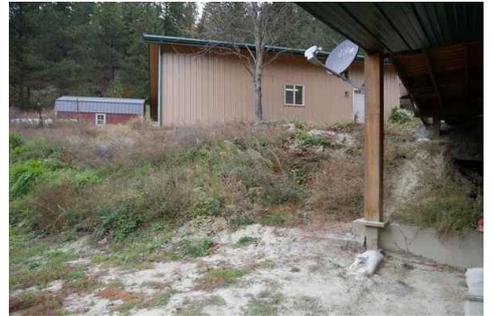
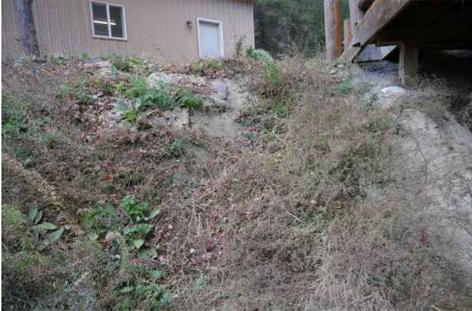
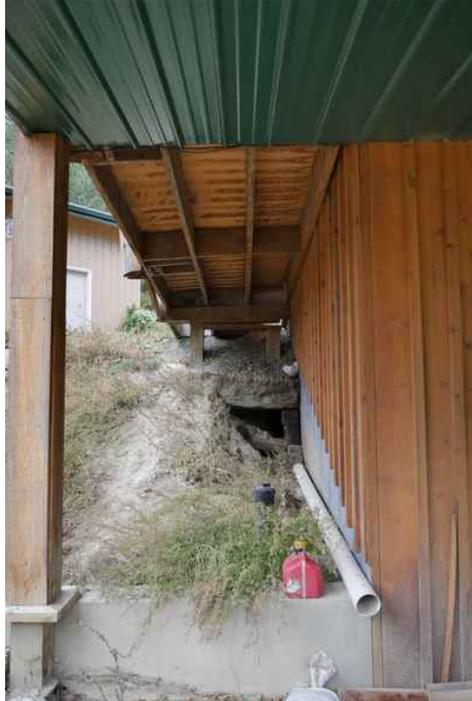
We observed numerous old sandbags that appeared to be used in an attempt to hold back mud and/or water, due to erosion.

West Side Water Erosion/Mud Slide

Mud Slide

Mud Entering Basement Concrete Area

West Side Mud Invasion

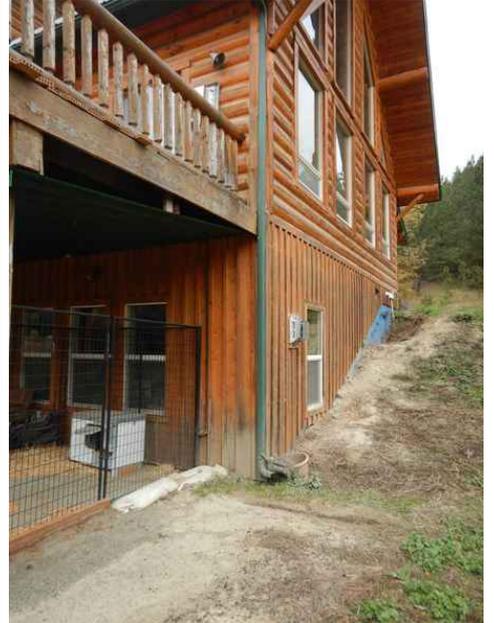
East Side Erosion

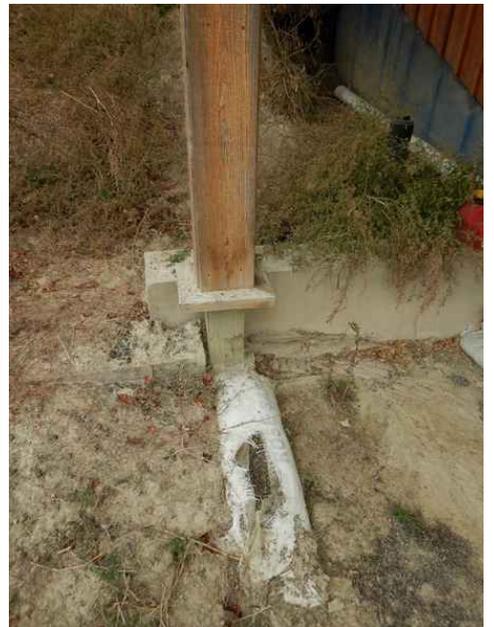
Old Sandbag

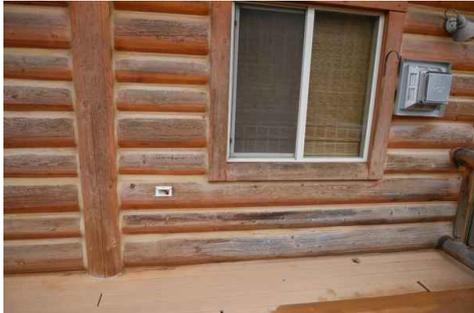
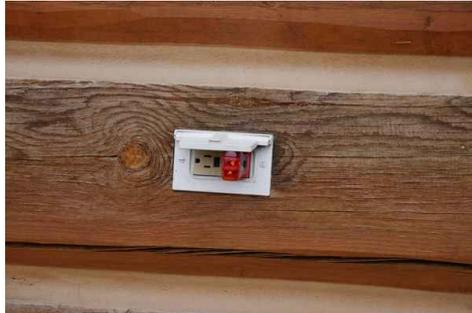
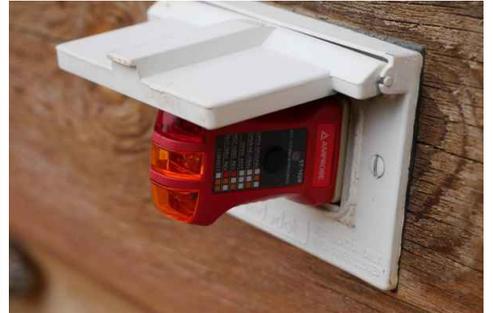
Southside Deck

One outside outlet is not working. Repair recommended.

Contact a qualified professional.

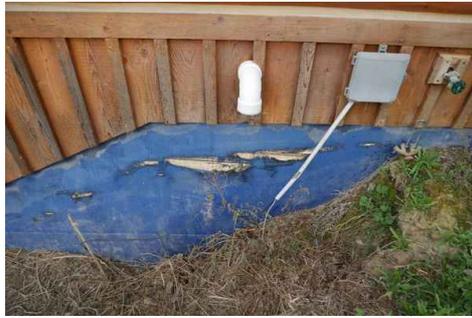
We observed a wire bundle protruding from the telco box.

Romex and Cat3 Wires Exposed

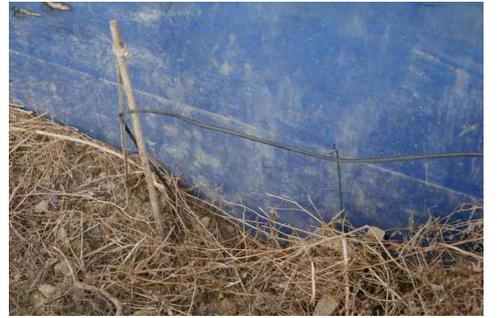
Black Wire Shoved Into the Ground

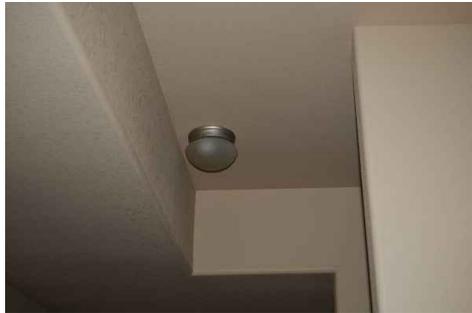
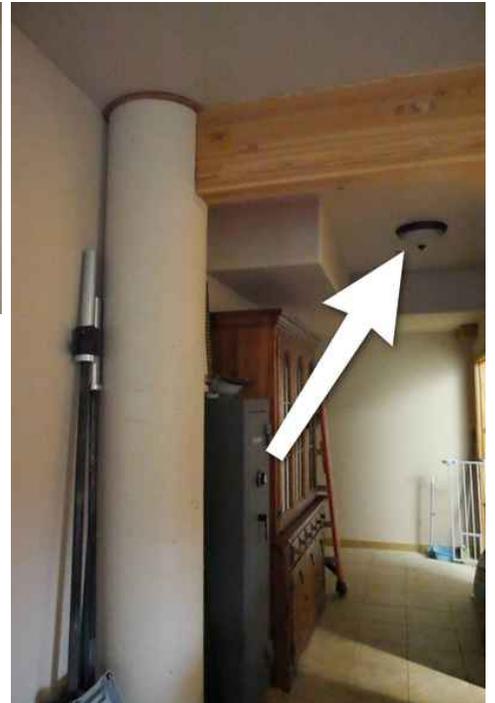
Light Fixtures: Some ceiling light fixtures/fans were in working condition at the time of the inspection. Light fixtures by basement stairs were not working.

Non-Working Light Fixture

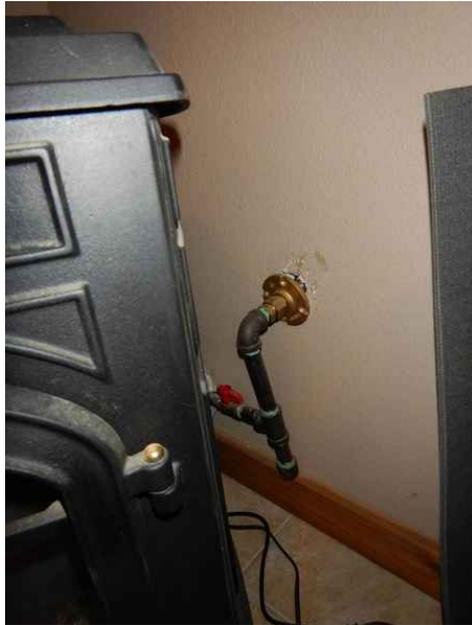
Propane supply pipe is detached from the wall.
Repair recommended by a qualify professional.

Propane Supply Pipe

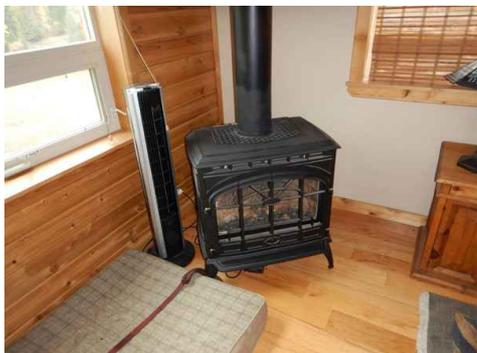
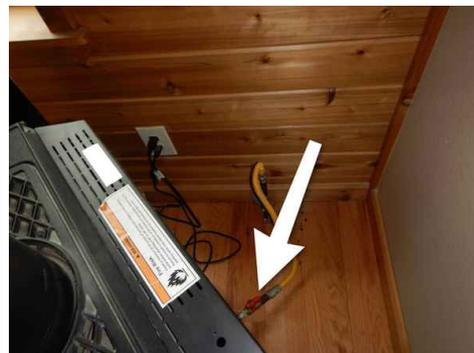
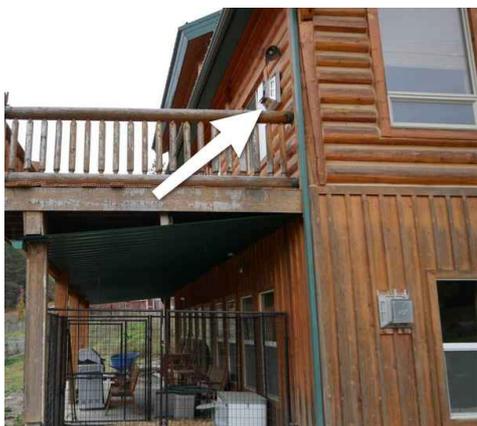
Propane stove was not inspected due to being turned off.

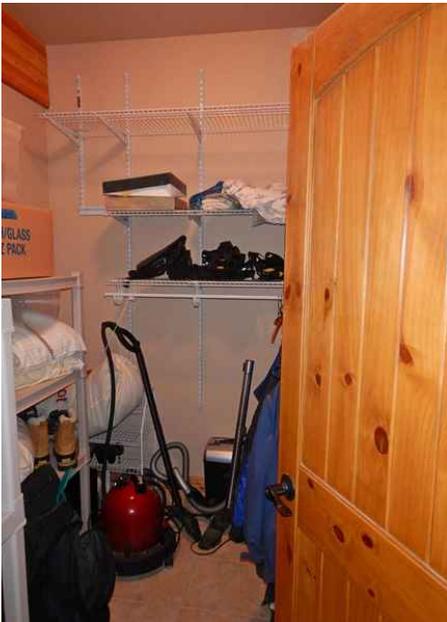
Second Storage Room Overview

Basement storage room is in overall good condition.

Ceiling: Drywall ceiling is in overall good condition.

Floor: Tile floor is in overall good condition. No cracks or missing grout was detected at the time of the inspection.

Walls: Walls in the basement storage room is in overall good condition.

Doors: Door in basement storage room is overall in good condition.

Light Fixtures: Ceiling light fixture was in working condition at the time of the inspection.

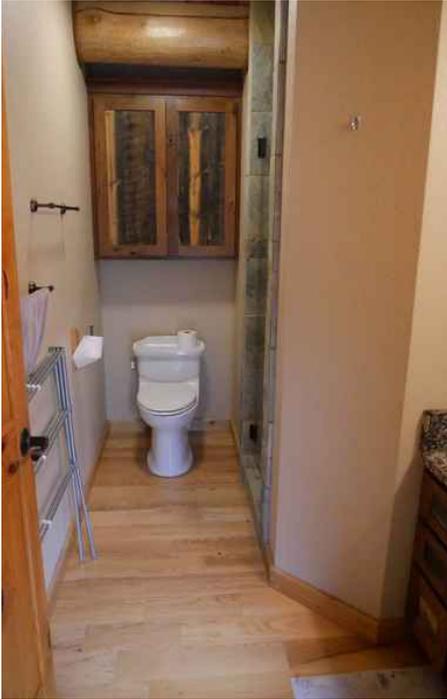
Bathroom Overview

Main Level Bathroom is in overall in good condition.

Ceiling: Tongue and groove ceiling was in overall good condition. There were no signs of water damage at the time of the inspection.

Floor: Wood floor in the main level bathroom was in overall good condition, and there were no signs of damage at the time of the inspection.

Walls: The walls were in overall good condition.

Toilet: Toilet was in working condition a the time of the inspection. No leaks were detected at the time of the inspection.

Shower: Shower was in working condition at the time of the inspection.

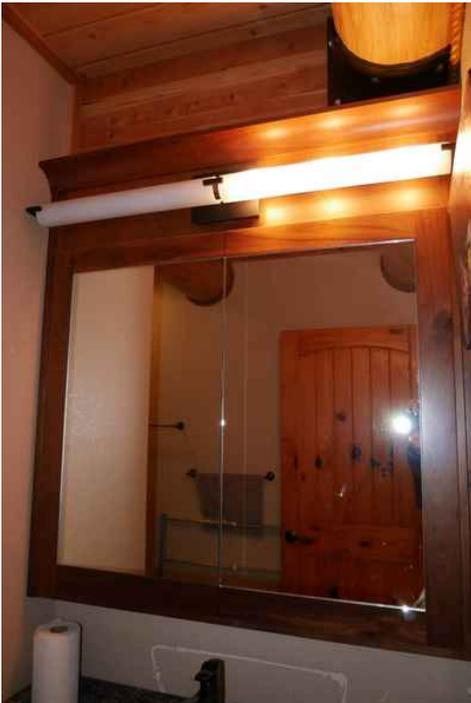
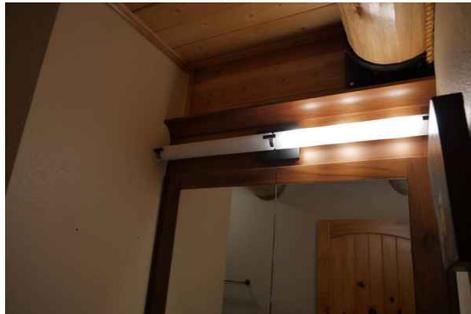
Part of over the sink light fixture in this bathroom is not working. Recommended repair by a qualify professional.

Recommended DIY Project

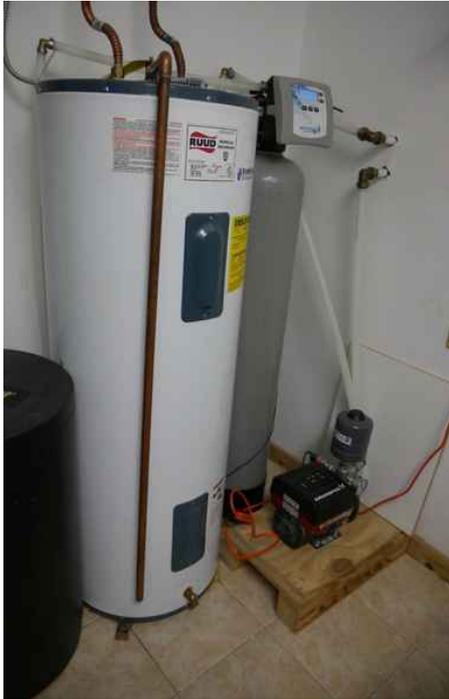
Booster Pump Location

It was in working condition at the time of the inspection.

Booster system pump is designed for domestic and commercial water supply, pressure boosting. It keeps a constant pressure in the pipe system. A pressure sensor monitoring discharge pressure will signal to the speed controller to change the motor speed to adapt the performance to the new situation.

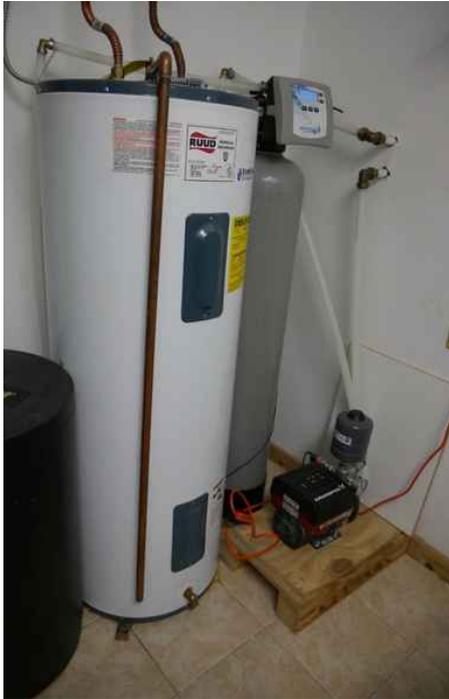
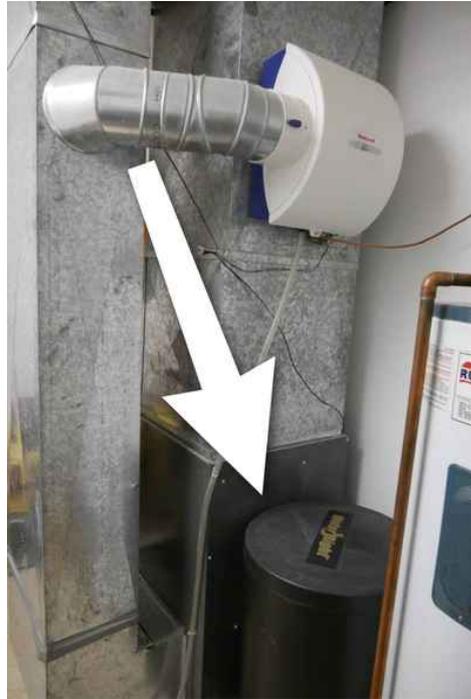
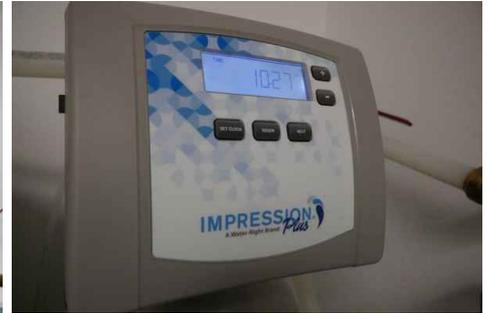
Water Softener Location

Impression Plus Series Water Softeners was installed in laundry/utility room. No leaks were detected at the time of the inspection.

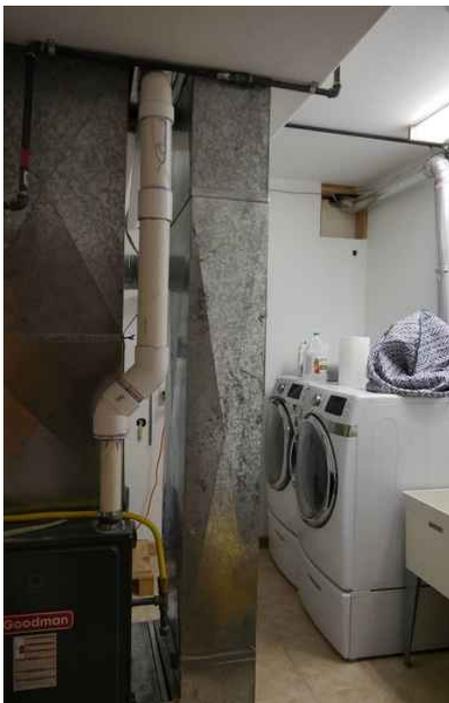
Laundry/Utility Room Overview

This room is overall in good condition. There were no leaks on ceiling, walls, and floor detected at the time of the inspection.

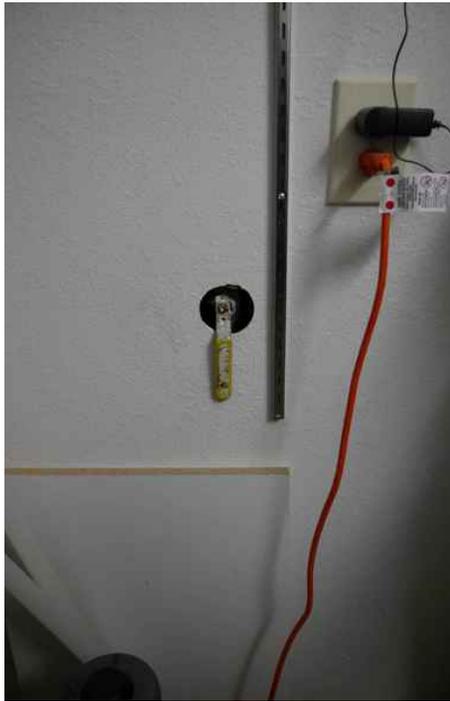
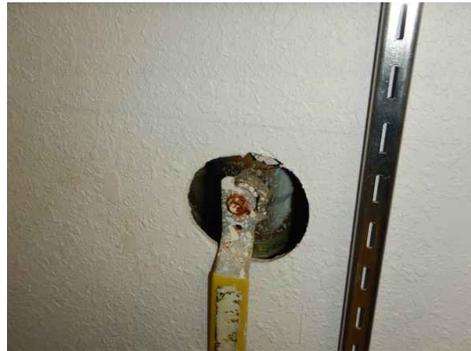
Main Water Shut Off

Main water shut off valve was located in the basement in utility/laundry room.

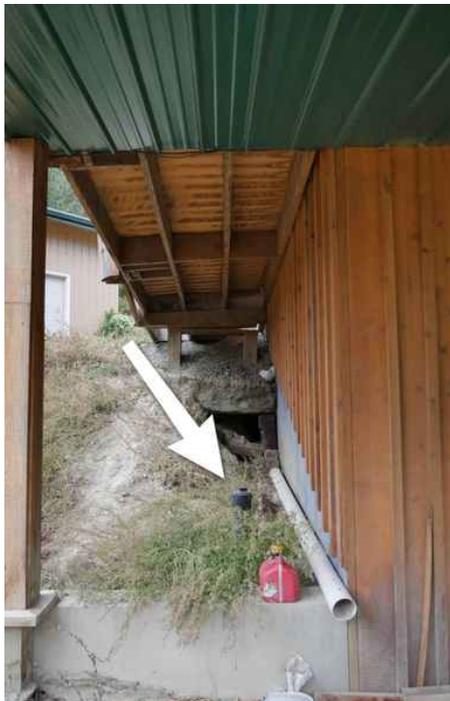
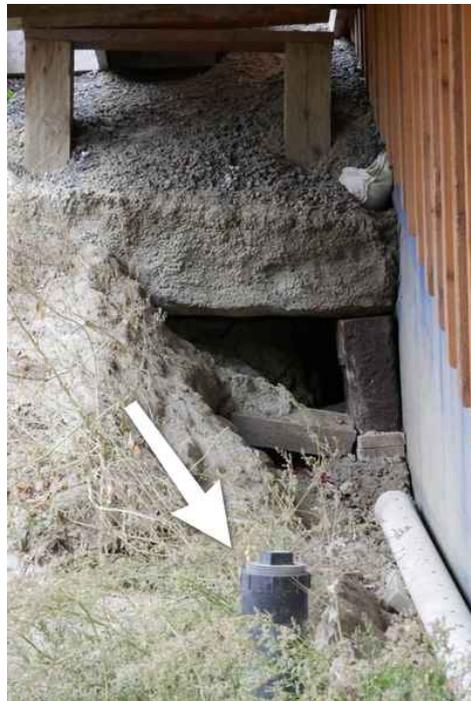
Septic Clean Out

Septic clean out pipe is on the southside of the house.

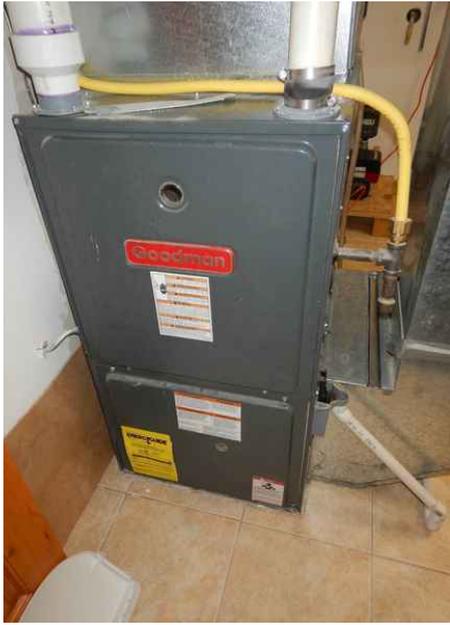
Furnace Location

Furnace was inspected via thermostat. It was in working condition at the time of the inspection.

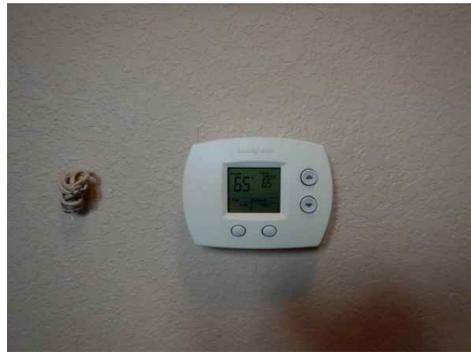
Thermostat Location

Furnace thermostat is located near loft stairs.

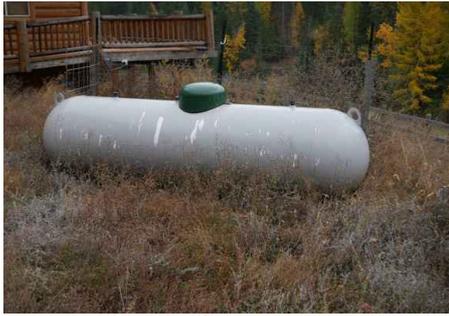
Gas Tank Location

Main gas shut off valve is located on the tank. The gas tank is located south/west from the house.

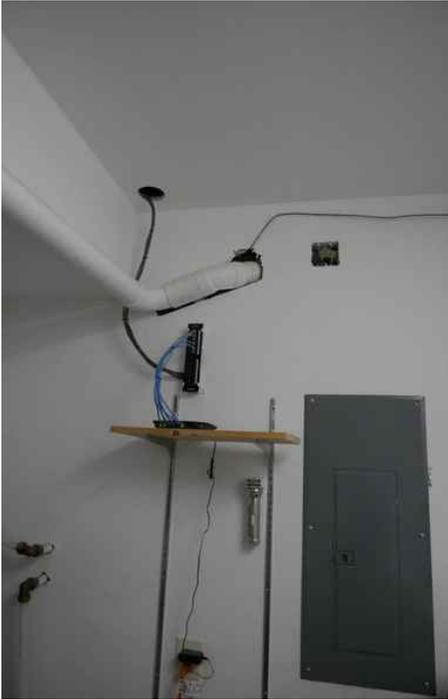
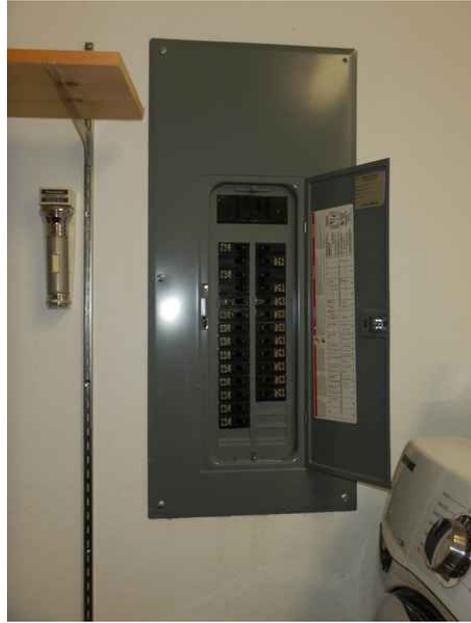
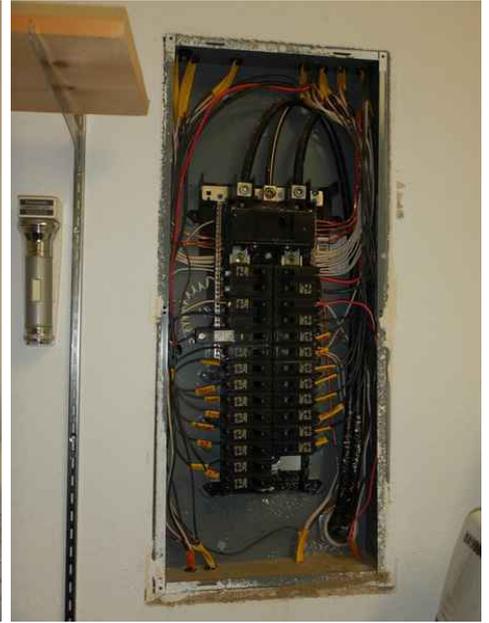
Main Panel Location

Electrical system is in overall good condition. The main circuit panel is located in laundry/utility room. Main panel is Square D system with Romex wiring. Main panel wiring appears to be in correctly wired.

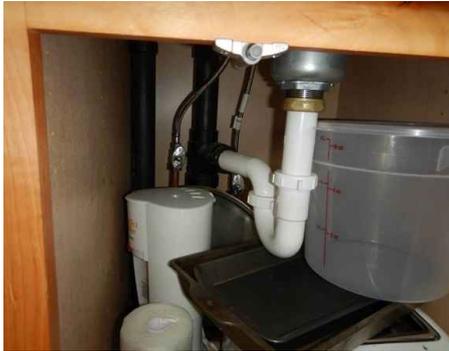
P-trap, Shut Off Valves Under the Sink

Plumbing appears to be in overall good condition. There were no leaks detected at the time of the inspection. Plumbing under the sinks has P-traps and individual shut off valves installed. Toilets have individual shut off valves installed also. Water pressure is 30 PSI.

NOTE: 30-80 PSI is considered acceptable.

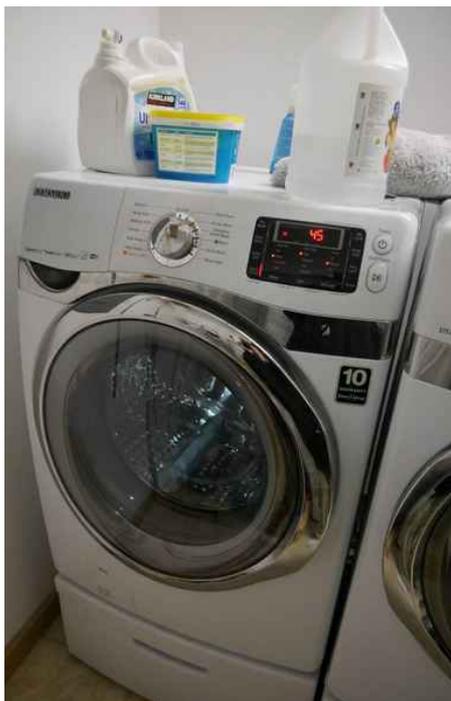
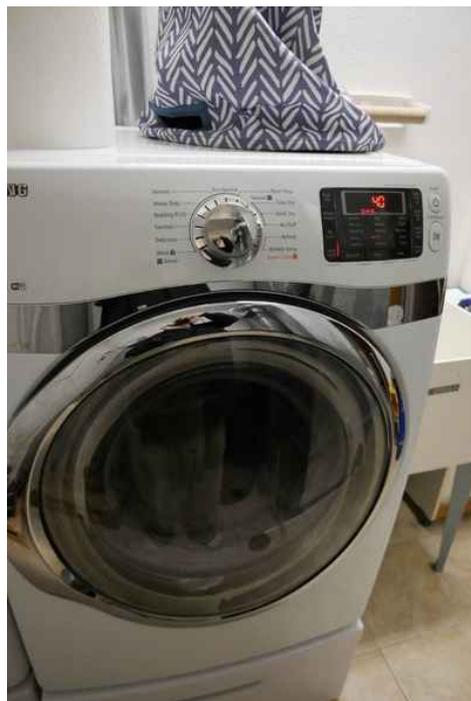
Samsung washer and dryer appear to be in working condition.

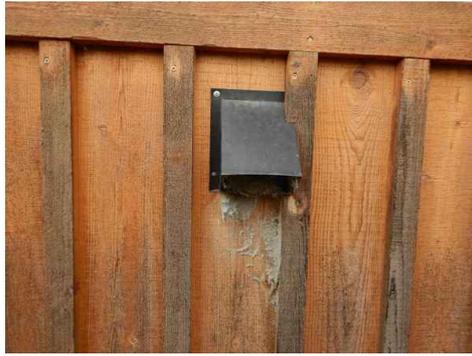
Dryer Vent

Lint in the dryer vent can cause fire. Cleaning recommended.

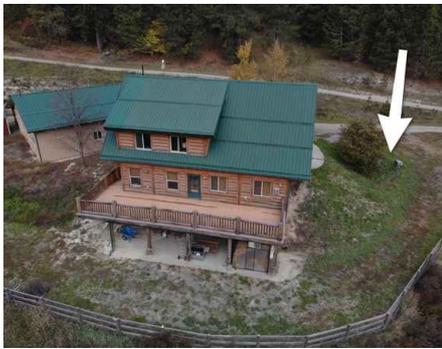
Service Entrance and Meter

Below Ground, Copper, 220 Volts

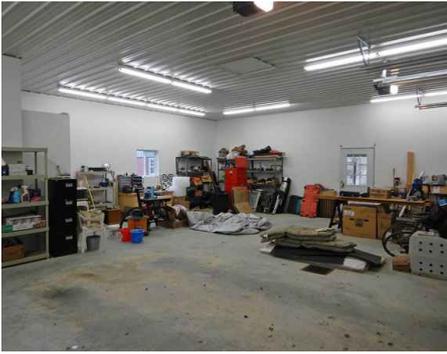
The walls in the garage are overall in good condition.

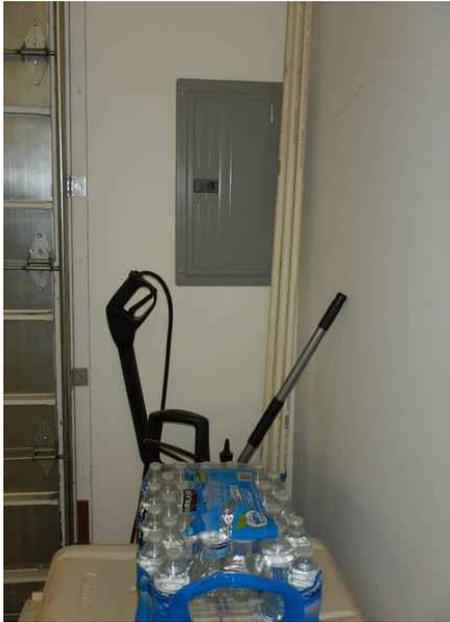
Electrical Sub-Panel

Electrical sub-panel could not be inspected in details, it has stuff in front of it .
Light fixtures were in working condition at the time of the inspection.
One receptacle does not work.

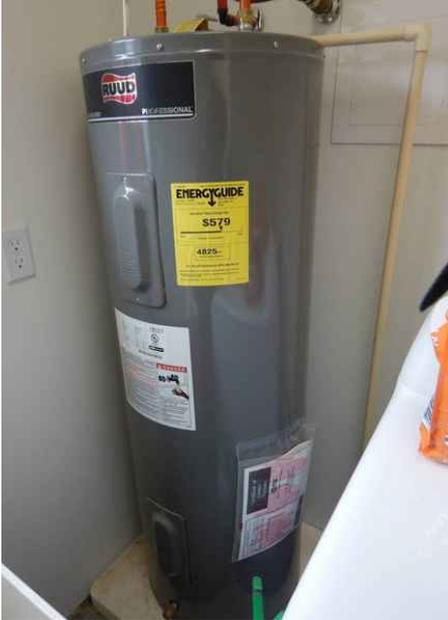
Water Heater

Water Heater: Water heater was in working condition at the time of the inspection.

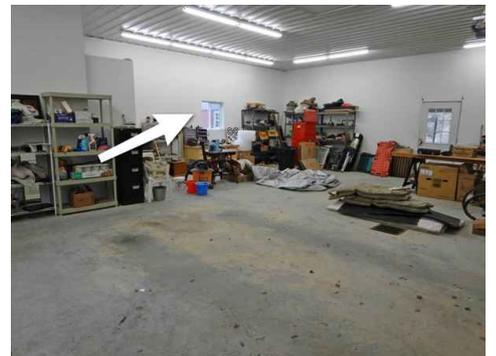
Obstructed Window

One window in the garage could not be inspected due to stuff blocking the pathway.

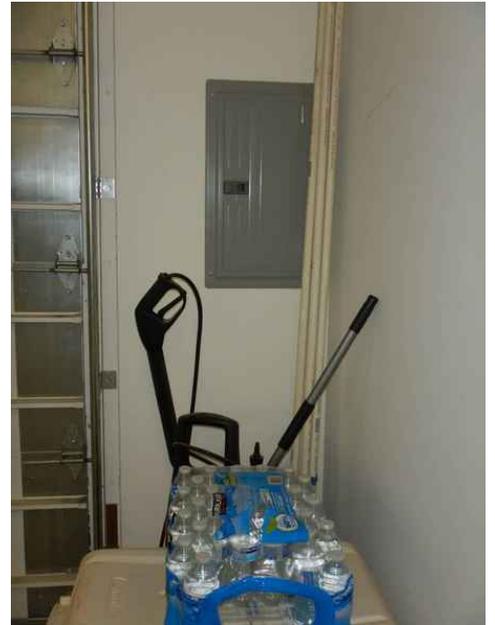
Obstruct Sub-Panel

Sub-panel could not be detailed inspected due to stuff in front of it.

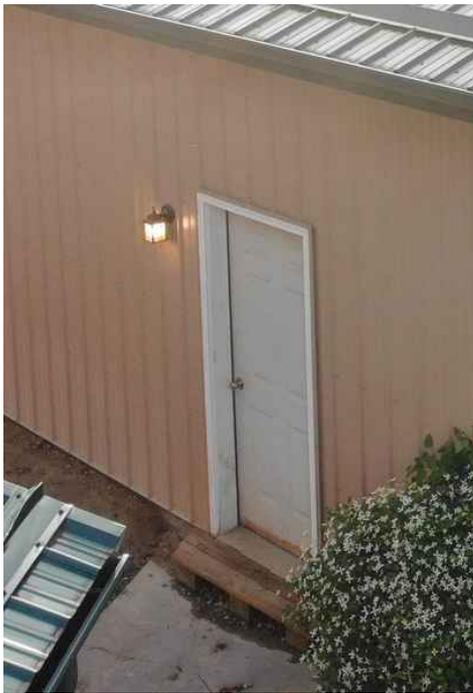
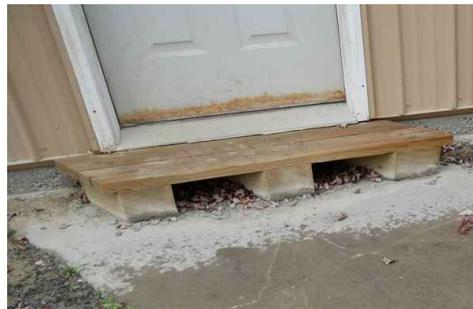
RUST ON THE BOTTOM OF THE DOOR

There was rust observed at the bottom of the side garage door. No other signs of water intrusion were observed at the time of the inspection.

Contact a qualified professional.

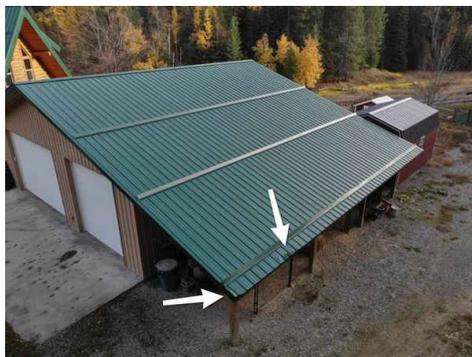
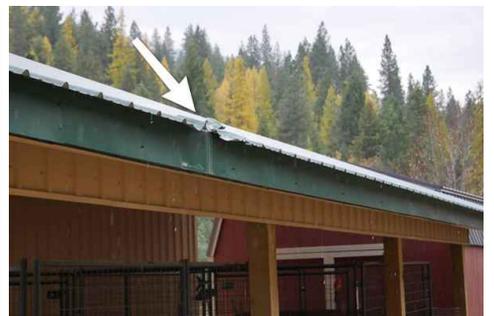
DAMAGED (GENERAL)

There is notable damage on the north corner of the roof.

Recommend a qualified roofing professional evaluate and repair.

Contact a qualified roofing professional.

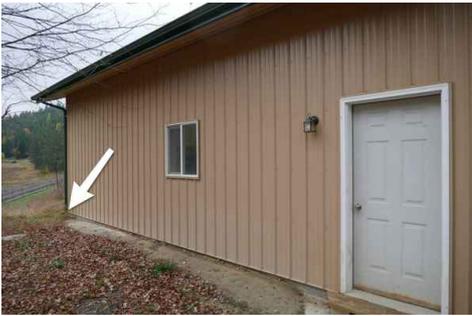
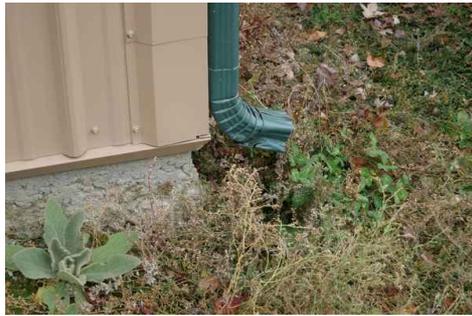
18.2.1 Roof Drainage Systems

DOWNSPOUTS DRAIN NEAR HOUSE

One or more downspouts drain too close to the home's foundation. This can result in excessive moisture in the soil at the foundation, which can lead to foundation/structural movement. Recommend a qualified contractor adjust downspout extensions to drain at least 3 feet from the foundation.

Contact a qualified roofing professional.

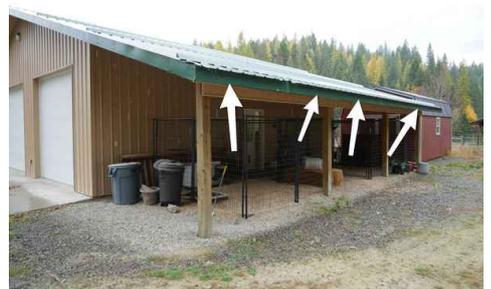
Missing Gutters

GUTTERS ARE MISSING

There are no gutters present on the westside of the structure. Gutters are recommended because they collect rain water from the roof and direct it away form the building.

Contact a qualified handyman.

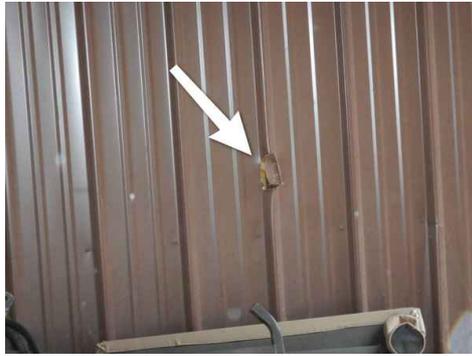
Outside Hole

Exterior walls were in overall good condition at the time of the inspection. There is a small hole that was observed in the siding.
