IDAHO SKY
208.267.0540
netmail@idahosky.com
<https://www.idahosky.com>

ROOM-BY-ROOM RESIDENTIAL DEMO

1234 Demonstration Report 1
Bonners Ferry ID 83805

Mr Anderson
NOVEMBER 17, 2021

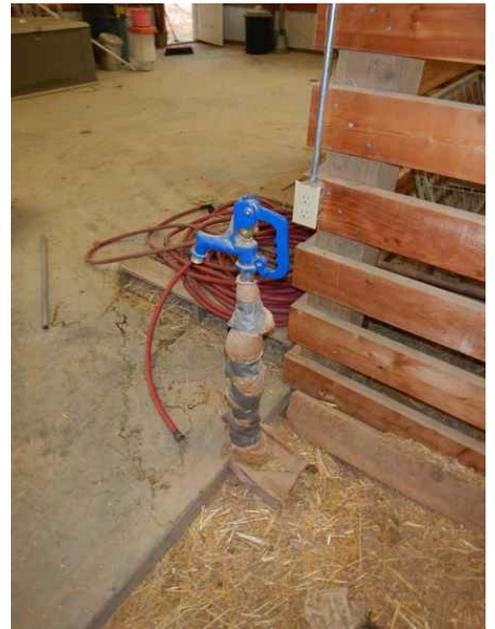
19.7.1 Electrical / Plumbing

FROST FREE SPIGOT

The frost free spigot has no water pressure.

Contact a qualified professional.

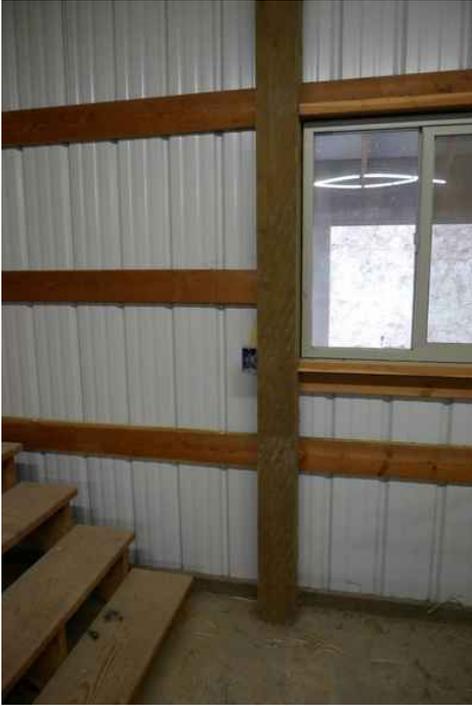
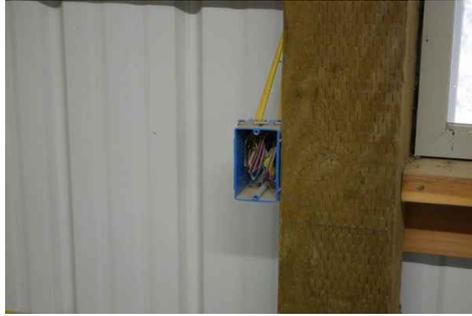
19.7.2 Electrical / Plumbing

COVER PLATES MISSING

One receptacle is missing a cover plate. This causes short and shock risk. Recommend installation of a plate.

Contact a handyman or DIY project

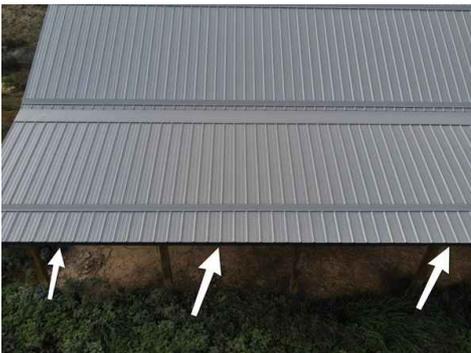
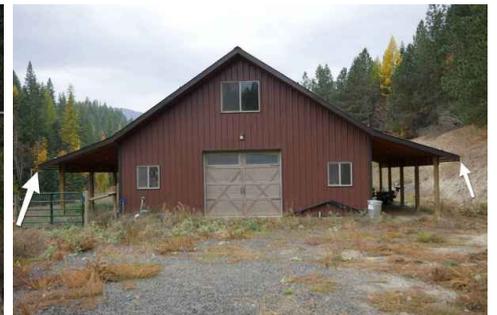
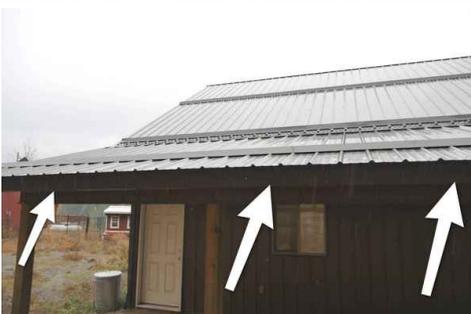
20.2.1 Roof Drainage Systems

GUTTERS MISSING

There are no gutters present on the structure. Gutters are recommended because they collect rain water from the roof and direct it away from the building.

Contact a qualified gutter contractor

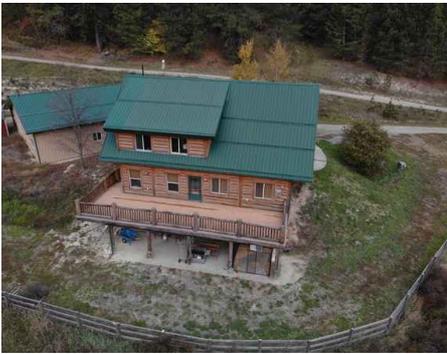
We inspected the roof, interior, and exterior of the home using FLIR Thermal Imaging cameras. Our general observations detected no safety issues or serious energy loss anomalies. The outside temperature was roughly 36 degrees. The ambient temperature inside of the home was 65 degrees. All photos can be viewed in the attached Thermal Imaging reports.
